Access Compliance Report

Public Rights-of-Way

(Curb Ramps)

Intersection ID: 46693	Main Street: GOLDFIELDS_DR	Cross Street: OLD_MEADOW_RD	Location: SE
ADA ID: A3176BFCA7FD	Ramp Type: BlendTrans2	Initial Pass/Fail: Fail	Overall Compliance: No
		Severity Score: 21.25

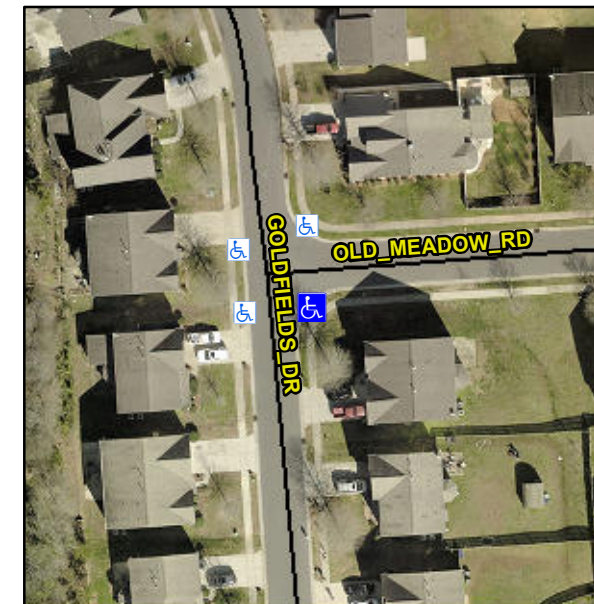
Not Found, R304.5.1, R304.5.3

Compliance	Description	Data	Compliance	Description	Data
N/A	Ramp Length (in)	95.0	Yes	BlendTrans Slope (%)	3.3
No	Ramp Width (in)	43.0	No	BlendTrans XSlope (%)	5.7
N/A	Flare Type LT	N/A	N/A	Flare Type RT	N/A
N/A	Flare Slope LT (%)	N/A	N/A	Flare Slope RT (%)	N/A
N/A	Flare Traversable LT?	N/A	N/A	Flare Traversable RT?	N/A
N/A	Landing Length (in)	N/A	N/A	DWS Provided?	N/A
N/A	Landing Width (in)	N/A	N/A	DWS Contrast?	N/A
N/A	Landing Slope (%)	N/A	N/A	DWS Length (in)	N/A
N/A	Landing X Slope (%)	N/A	N/A	DWS Full Width?	N/A
N/A	Landing Curb? (Y/N)	N/A	N/A	DWS Offset (in)	N/A
N/A	Shared Landing?	N/A			
N/A	Gutter Ponding?	N/A	N/A	Gutter Slope (%)	N/A
N/A	Gutter Lip Ht (in)	N/A	N/A	Gutter X Slope (%)	N/A
N/A	Painted X Walk1?	No	N/A	Painted X Walk2?	No
	X Walk 1 Direction	To N		X Walk 2 Direction	To W
	X Walk 1 Width (in)	N/A		X Walk 2 Width (in)	N/A
	X Walk 1 Slope (%)	4.9		X Walk 2 Slope (%)	3.0
	X Walk 1 X Slope (%)	0.8		X Walk 2 X Slope (%)	3.0

N/A	Ramp inside XWalk1?	N/A	N/A	Ramp inside XWalk2?	N/A
	Road Slope (%)	1.5		Clear Space?	N/A
	Road X Slope (%)	6.9	N/A	Clear Space to XWalk (in)	N/A
N/A	Any Obstructions?	N/A	N/A	Storm Grate/Utility Hazard?	N/A
	Obstruction Type			Storm Grate/Utility Type	
		N/A			N/A
			Yes	Surface Condition? (G/P)	Good
			No	Curb Slope (%)	9.9

Remove & Replace Curb Ramp With Two New Directional Ramps or Equivalent.
