Access Compliance Report

Public Rights-of-Way

(Curb Ramps)

Intersection ID: 49555	Main Street: ARTISTS_WY	Cross Street: STEEL_GARDENS_BV	Location: S
ADA ID: A31A1233B883	Ramp Type: Perp	Initial Pass/Fail: Fail	Overall Compliance: No
Severity Score: 21.25			
Codes/Mitigation Info/Possible Solution		Field Measurements/Component Compliance

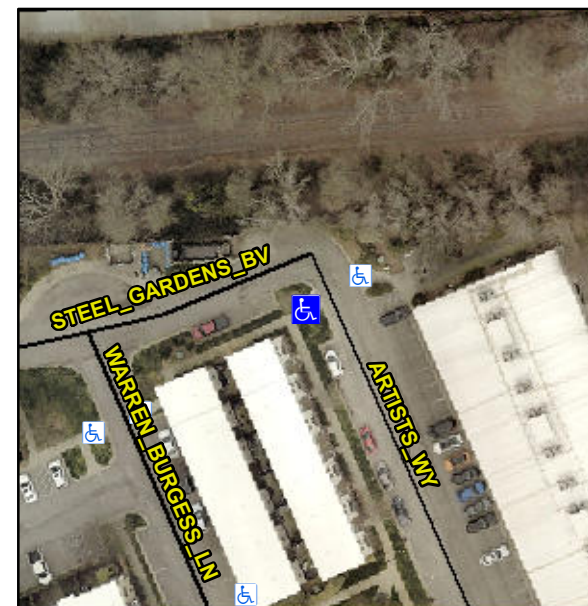
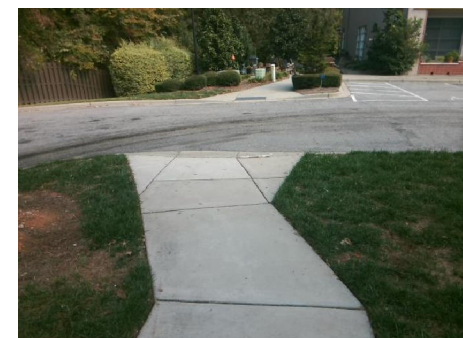
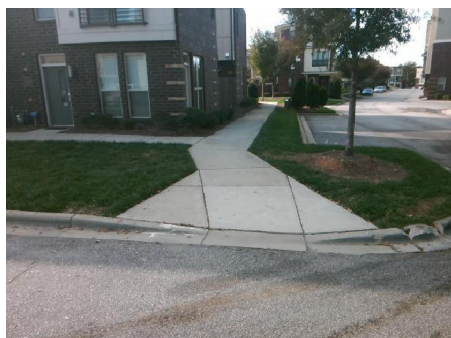
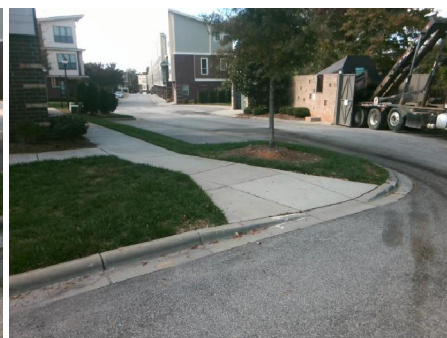
R304.5.1, R304.2.2

Compliance	Description	Data	Compliance	Description	Data
N/A	Ramp Length (in)	100.0	No	Ramp Slope (%)	8.4
No	Ramp Width (in)	47.0	Yes	Ramp XSlope (%)	1.0
N/A	Flare Type LT	N/A	N/A	Flare Type RT	N/A
N/A	Flare Slope LT (%)	N/A	N/A	Flare Slope RT (%)	N/A
N/A	Flare Traversable LT?	N/A	N/A	Flare Traversable RT?	N/A
N/A	Landing Length (in)	N/A	N/A	DWS Provided?	N/A
N/A	Landing Width (in)	N/A	N/A	DWS Contrast?	N/A
N/A	Landing Slope (%)	N/A	N/A	DWS Length (in)	N/A
N/A	Landing X Slope (%)	N/A	N/A	DWS Full Width?	N/A
N/A	Landing Curb? (Y/N)	N/A	N/A	DWS Offset (in)	N/A
N/A	Shared Landing?	N/A			
N/A	Gutter Ponding?	N/A	N/A	Gutter Slope (%)	N/A
N/A	Gutter Lip Ht (in)	N/A	N/A	Gutter X Slope (%)	N/A
N/A	Painted X Walk1?	No	N/A	Painted X Walk2?	N/A
	X Walk 1 Direction	To NE		X Walk 2 Direction	N/A
N/A	X Walk 1 Width (in)	N/A	N/A	X Walk 2 Width (in)	N/A
	X Walk 1 Slope (%)	3.4		X Walk 2 Slope (%)	N/A
	X Walk 1 X Slope (%)	2.6		X Walk 2 X Slope (%)	N/A

N/A	Ramp inside XWalk1?	N/A	N/A	Ramp inside XWalk2?	N/A
	Road Slope (%)	N/A	N/A	Clear Space?	N/A
	Road X Slope (%)	N/A	N/A	Clear Space to XWalk (in)	N/A
N/A	Any Obstructions?	N/A	N/A	Storm Grate/Utility Hazard?	N/A
	Obstruction Type			Storm Grate/Utility Type	
		N/A			N/A
			Yes	Surface Condition? (G/P)	Good

Remove & Replace Entire Ramp.
