# Access Compliance Report

## Public Rights-of-Way

| Intersection ID: 32180 | Main Street: REAVENCREST_PARK_DR | Cross Street: VERDUGO_DR | Location: SE |
| ADA ID: A332645B709F | Ramp Type: PerpDiag | Initial Pass/Fail: Fail | Overall Compliance: No |

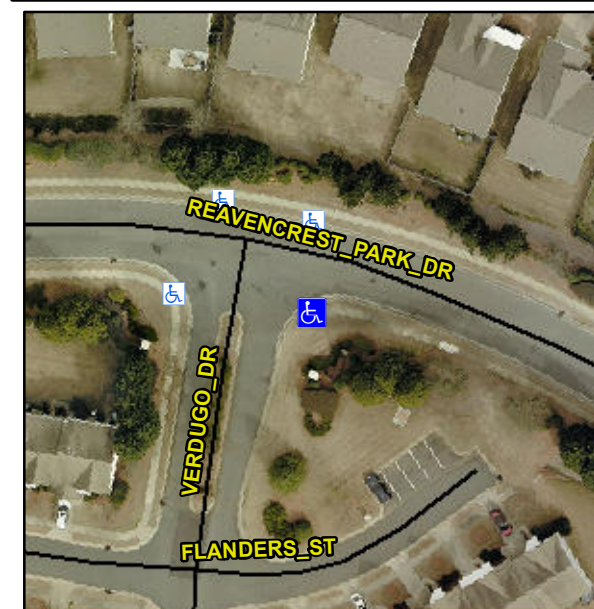
| Severity Score: 22.5 | | | |

**Not Found, R304.5.1, R304.2.2, R304.5.3**

| Compliance | Description | Data | Compliance | Description | Data |
|---|---|---|---|---|---|
| N/A | Ramp Length (in) | 48.0 | No | Ramp Slope (%) | 10.7 |
| No | Ramp Width (in) | 46.0 | No | Ramp XSlope (%) | 4.7 |

**Remove & Replace Curb Ramp With Two New Directional Ramps or Equivalent.**

Total Cost: \$ 3200.00
