# Access Compliance Report

## Public Rights-of-Way

### (Curb Ramps)

| Intersection ID: 48644 | Main Street: SOCATA_WY | Cross Street: ROCKY_FORD_CLUB_RD | Location: | N |

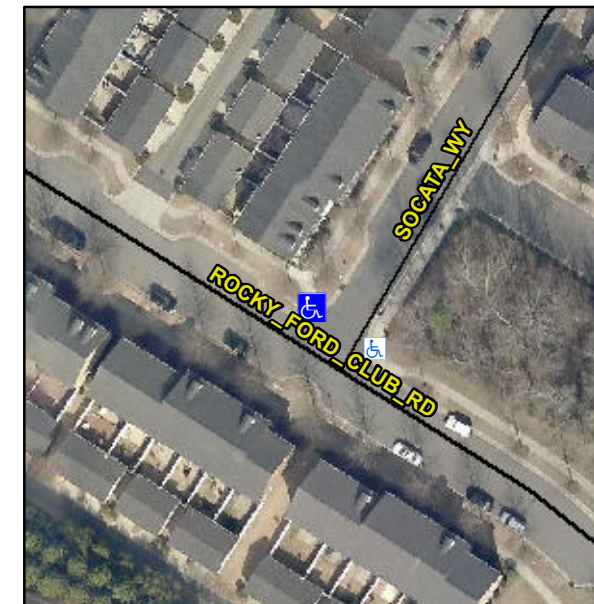
| ADA ID: A3333496489A | Ramp Type: Perp | Initial Pass/Fail: Pass | Overall Compliance: No | Severity Score: 7.5 |

**R304.2.2-Perp, R304.3.2-Para,  
R304.5.3, R305.1.4, R302.7, R304.5.4**

| Compliance | Description | Data | Compliance | Description | Data |
|---|---|---|---|---|---|
| No | Landing Slope (%) | 2.6 | Yes | DWS Length (in) | 24.0 |
| No | Landing X Slope (%) | 3.1 | No | DWS Full Width? | No |
| No | Gutter Ponding? | Yes | No | Gutter Slope (%) | 5.1 |

**Remove & Replace Entire Ramp.  
Remove & Replace Gutter.**
