## **Access Compliance Report Public Rights-of-Way** (Curb Ramps)

Intersection ID: 5213 Main Street: NORTHPARK BV **Cross Street: REAMES RD** Location:

ADA ID: A333AE2D28D4 Ramp Type: PerpDiag Initial Pass/Fail: Fail **Overall Compliance: No** Severity Score: 21.25

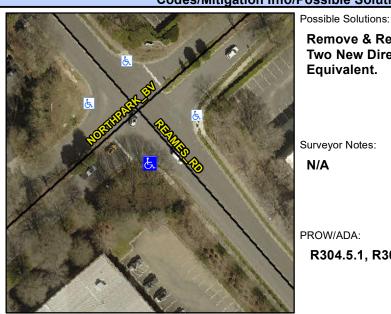
Compliance Description		Data	Comp	oliance	Description	Data
N/A	Ramp Length (in)	52.0	No	Ramp	Slope (%)	8.6
No	Ramp Width (in)	47.0	Yes	Ramp	XSlope (%)	0.7
N/A	Flare Type LT	N/A	N/A	Flare	Type RT	N/A
N/A	Flare Slope LT (%)	N/A	N/A	Flare	Slope RT (%)	N/A
N/A	Flare Traversable LT?	N/A	N/A	Flare	Traversable RT?	N/A
N/A	Landing Length (in)	N/A	N/A	DWS	Provided?	N/A
N/A	Landing Width (in)	N/A	N/A	DWS	Contrast?	N/A
N/A	Landing Slope (%)	N/A	N/A	DWS	Length (in)	N/A
N/A	Landing X Slope (%)	N/A	N/A	DWS	Full Width?	N/A
N/A	Landing Curb? (Y/N)	N/A	N/A	DWS	Offset (in)	N/A
N/A	Shared Landing?	N/A				
N/A	Gutter Ponding?	N/A	N/A	Gutte	r Slope (%)	N/A
N/A	Gutter Lip Ht (in)	N/A	N/A	Gutte	r X Slope (%)	N/A
N/A	Painted X Walk1?	No	N/A	Paint	ed X Walk2?	No
	X Walk 1 Direction	To NE		X Wa	lk 2 Direction	To NW
N/A	X Walk 1 Width (in)	N/A	N/A	X Wa	lk 2 Width (in)	N/A
	X Walk 1 Slope (%)	2.3		X Wa	lk 2 Slope (%)	3.7
	X Walk 1 X Slope (%)	8.4		X Wa	lk 2 X Slope (%)	3.6

N/A	Ramp inside XWalk1?	N/A	N/A	Ram	inside XWalk2?	N/A
	Road Slope (%)	4.2	N/A	Clear	Space?	N/A
	Road X Slope (%)	2.5	N/A	Clear	Space to XWalk (in)	N/A
N/A	Any Obstructions?	N/A	N/A	Storn	n Grate/Utility Hazard?	N/A
	Obstruction Type			Storn	n Grate/Utility Type	
		N/A				N/A
			١.,		/

**REAMES RD** Street 1 Name Stop Condition-Street 2 None Street 2 Name **NORTHPARK BV** Stop Condition-Street 1 StopSign **Remove & Replace Curb Ramp With Two New Directional Ramps or** Equivalent.

R304.5.1, R304.2.2
