Intersection ID: 10040791	Main Street: W_W_T_HARRIS_BV	Cross Street: N/A	Location:	NE
ADA ID: A3454FEAE495	Ramp Type: BlendTrans1	Initial Pass/Fail: Fail	Overall Compliance: No	Severity Score: 1.25

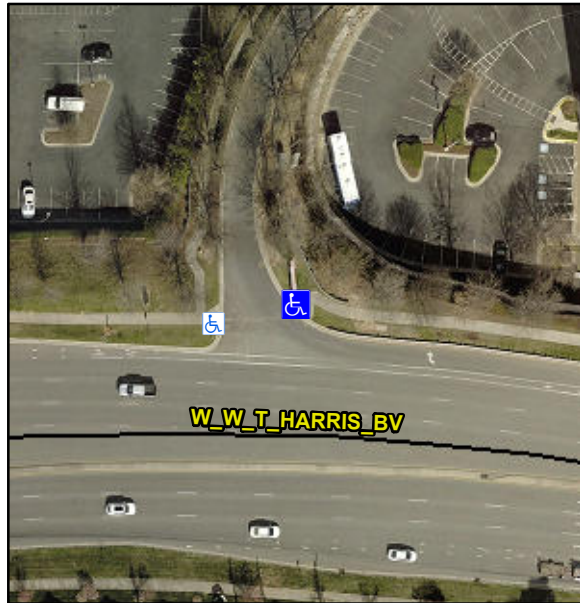
CURB LIP 1.0

Not Found, R304.5.3, R304.4.1

Compliance	Description	Data	Compliance	Description	Data
N/A	Ramp Length (in)	96.0	No	BlendTrans Slope (%)	5.5
Yes	Ramp Width (in)	48.0	No	BlendTrans XSlope (%)	4.5
N/A	Flare Type LT	N/A	N/A	Flare Type RT	N/A
N/A	Flare Slope LT (%)	N/A	N/A	Flare Slope RT (%)	N/A
N/A	Flare Traversable LT?	N/A	N/A	Flare Traversable RT?	N/A
N/A	Landing Length (in)	N/A	N/A	DWS Provided?	N/A
N/A	Landing Width (in)	N/A	N/A	DWS Contrast?	N/A
N/A	Landing Slope (%)	N/A	N/A	DWS Length (in)	N/A
N/A	Landing X Slope (%)	N/A	N/A	DWS Full Width?	N/A
N/A	Landing Curb? (Y/N)	N/A	N/A	DWS Offset (in)	N/A
N/A	Shared Landing?	N/A			
N/A	Gutter Ponding?	N/A	N/A	Gutter Slope (%)	N/A
N/A	Gutter Lip Ht (in)	N/A	N/A	Gutter X Slope (%)	N/A
N/A	Painted X Walk1?	No	N/A	Painted X Walk2?	No
	X Walk 1 Direction	To W		X Walk 2 Direction	To S
	X Walk 1 Width (in)	N/A		X Walk 2 Width (in)	N/A
	X Walk 1 Slope (%)	2.5		X Walk 2 Slope (%)	1.6
	X Walk 1 X Slope (%)	0.5		X Walk 2 X Slope (%)	0.8

N/A	Ramp inside XWalk1?	N/A	N/A	Ramp inside XWalk2?	N/A
	Road Slope (%)	0.1		Clear Space?	N/A
	Road X Slope (%)	1.0	N/A	Clear Space to XWalk (in)	N/A
N/A	Any Obstructions?	N/A	N/A	Storm Grate/Utility Hazard?	N/A
	Obstruction Type			Storm Grate/Utility Type	
		N/A			N/A
			Yes	Surface Condition? (G/P)	Good
			No	Curb Slope (%)	7.8

Remove & Replace Curb Ramp With Two New Directional Ramps or Equivalent.

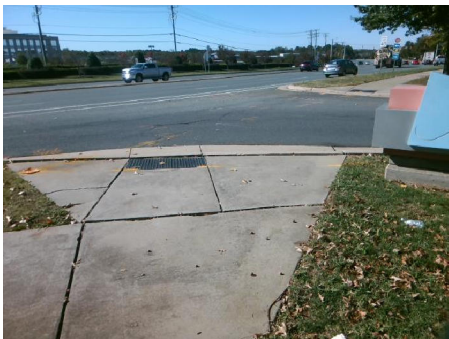
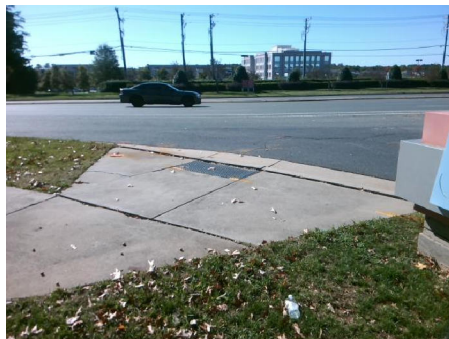
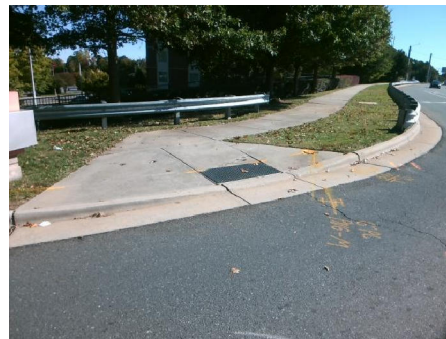
Street 1 Name	W W T HARRIS BV
Stop Condition-Street 1	None
Street 2 Name	N/A
Stop Condition-Street 2	None
