# Access Compliance Report

## Public Rights-of-Way

### (Curb Ramps)

Intersection ID: 4935	Main Street: OLD_STATESVILLE_RD	Cross Street: HENDERSON_CR	Location: NW
ADA ID: A3487E56653C	Ramp Type: Perp	Initial Pass/Fail: Fail	Overall Compliance: No
		Severity Score: 22.5

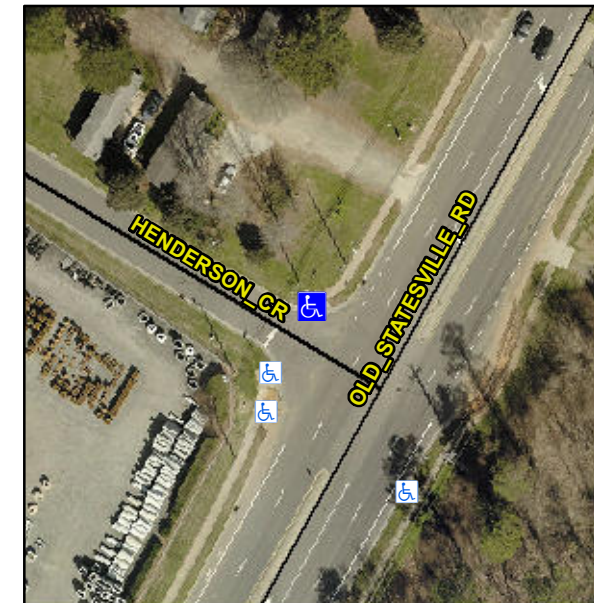
**Not Found, R304.5.1, R304.2.2, R304.5.3**

Compliance	Description	Data	Compliance	Description	Data
N/A	Ramp Length (in)	59.5	No	Ramp Slope (%)	10.8
No	Ramp Width (in)	36.5	No	Ramp XSlope (%)	3.1
N/A	Flare Type LT	N/A	N/A	Flare Type RT	N/A
N/A	Flare Slope LT (%)	N/A	N/A	Flare Slope RT (%)	N/A
N/A	Flare Traversable LT?	N/A	N/A	Flare Traversable RT?	N/A
N/A	Landing Length (in)	N/A	N/A	DWS Provided?	N/A
N/A	Landing Width (in)	N/A	N/A	DWS Contrast?	N/A
N/A	Landing Slope (%)	N/A	N/A	DWS Length (in)	N/A
N/A	Landing X Slope (%)	N/A	N/A	DWS Full Width?	N/A
N/A	Landing Curb? (Y/N)	N/A	N/A	DWS Offset (in)	N/A
N/A	Shared Landing?	N/A			
N/A	Gutter Ponding?	N/A	N/A	Gutter Slope (%)	N/A
N/A	Gutter Lip Ht (in)	N/A	N/A	Gutter X Slope (%)	N/A
N/A	Painted X Walk1?	No	N/A	Painted X Walk2?	N/A
	X Walk 1 Direction	To SW		X Walk 2 Direction	N/A
N/A	X Walk 1 Width (in)	N/A	N/A	X Walk 2 Width (in)	N/A
	X Walk 1 Slope (%)	1.2		X Walk 2 Slope (%)	N/A
	X Walk 1 X Slope (%)	2.9		X Walk 2 X Slope (%)	N/A

N/A	Ramp inside XWalk1?	N/A	N/A	Ramp inside XWalk2?	N/A
	Road Slope (%)	N/A	N/A	Clear Space?	N/A
	Road X Slope (%)	N/A	N/A	Clear Space to XWalk (in)	N/A
N/A	Any Obstructions?	N/A	N/A	Storm Grate/Utility Hazard?	N/A
	Obstruction Type			Storm Grate/Utility Type	
		N/A			N/A
			Yes	Surface Condition? (G/P)	Good

**Remove & Replace Entire Ramp.**
