Access Compliance Report

Public Rights-of-Way

(Curb Ramps)

Intersection ID: 30305	Main Street: GALLATIN_LN	Cross Street: RAVANNA_DR	Location:	N
ADA ID: A35A95C58758	Ramp Type: BlendTrans1	Initial Pass/Fail: Fail	Overall Compliance: No	Severity Score: 35
Codes/Mitigation Info/Possible Solution		Field Measurements/Component Compliance

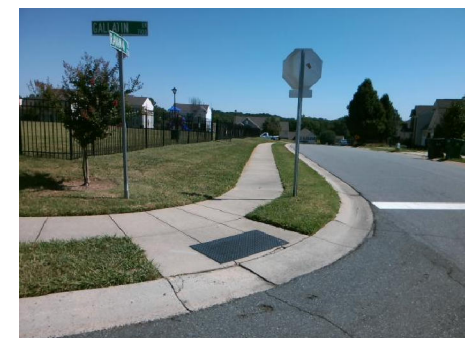
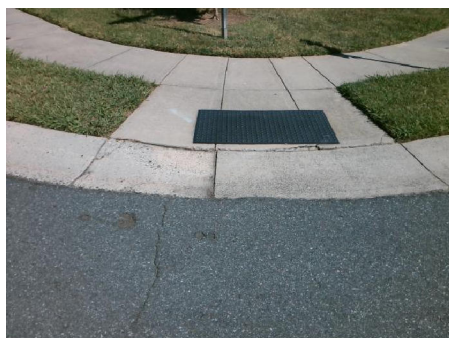
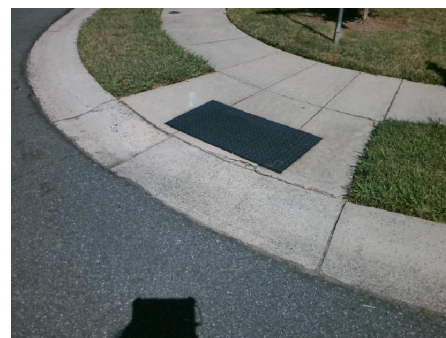
Not Found, R304.5.1

Compliance	Description	Data	Compliance	Description	Data
N/A	Ramp Length (in)	51.0	Yes	BlendTrans Slope (%)	4.1
No	Ramp Width (in)	28.0	Yes	BlendTrans XSlope (%)	1.1
N/A	Flare Type LT	N/A	N/A	Flare Type RT	N/A
N/A	Flare Slope LT (%)	N/A	N/A	Flare Slope RT (%)	N/A
N/A	Flare Traversable LT?	N/A	N/A	Flare Traversable RT?	N/A
N/A	Landing Length (in)	N/A	N/A	DWS Provided?	N/A
N/A	Landing Width (in)	N/A	N/A	DWS Contrast?	N/A
N/A	Landing Slope (%)	N/A	N/A	DWS Length (in)	N/A
N/A	Landing X Slope (%)	N/A	N/A	DWS Full Width?	N/A
N/A	Landing Curb? (Y/N)	N/A	N/A	DWS Offset (in)	N/A
N/A	Shared Landing?	N/A			
N/A	Gutter Ponding?	N/A	N/A	Gutter Slope (%)	N/A
N/A	Gutter Lip Ht (in)	1.0	N/A	Gutter X Slope (%)	N/A
N/A	Painted X Walk1?	No	N/A	Painted X Walk2?	No
	X Walk 1 Direction	To SW		X Walk 2 Direction	To SE
	X Walk 1 Width (in)	N/A		X Walk 2 Width (in)	N/A
	X Walk 1 Slope (%)	2.3		X Walk 2 Slope (%)	0.8
	X Walk 1 X Slope (%)	1.1		X Walk 2 X Slope (%)	2.1

N/A	Ramp inside XWalk1?	N/A	N/A	Ramp inside XWalk2?	N/A
	Road Slope (%)	1.0		Clear Space?	N/A
	Road X Slope (%)	2.0	N/A	Clear Space to XWalk (in)	N/A
N/A	Any Obstructions?	N/A	N/A	Storm Grate/Utility Hazard?	N/A
	Obstruction Type			Storm Grate/Utility Type	
		N/A			N/A
			Yes	Surface Condition? (G/P)	Good
			No	Curb Slope (%)	12.1

Remove & Replace Curb Ramp With Two New Directional Ramps or Equivalent.
