# Access Compliance Report

## Public Rights-of-Way

### (Curb Ramps)

Intersection ID: 9617	Main Street: CATALINA_AV	Cross Street: W_28TH_ST	Location: E
ADA ID: A36096B16363	Ramp Type: ParaDiag	Initial Pass/Fail: Fail	Overall Compliance: No
		Severity Score: 26.25

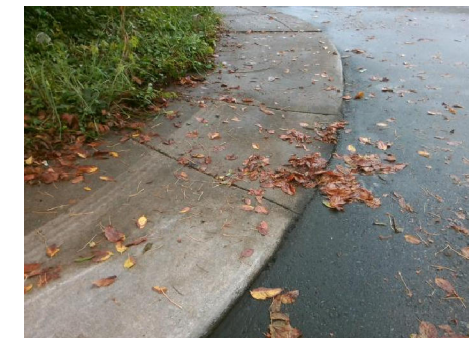
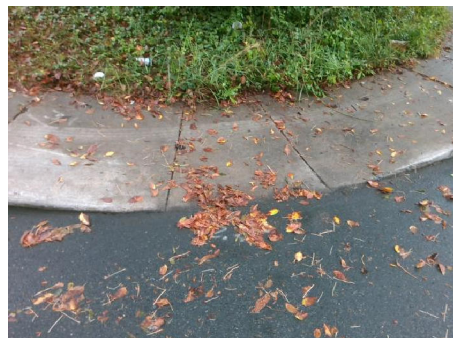
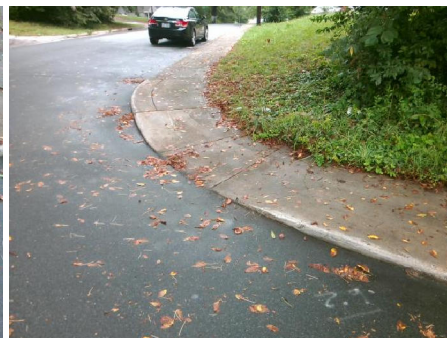
**RT RP < 5%**

Compliance	Description	Data	Compliance	Description	Data
N/A	Ramp Length LT (in)	47.0	N/A	Ramp Length RT (in)	76.0
Yes	Ramp Width LT (in)	49.0	Yes	Ramp Width RT (in)	51.0
No	Ramp Slope LT (%)	13.0	Yes	Ramp Slope RT (%)	4.2
No	Ramp XSlope LT (%)	3.3	No	Ramp XSlope RT (%)	2.5
N/A	Landing Length (in)	N/A	N/A	DWS Provided?	N/A
N/A	Landing Width (in)	N/A	N/A	DWS Contrast?	N/A
N/A	Landing Slope (%)	N/A	N/A	DWS Length (in)	N/A
N/A	Landing X Slope (%)	N/A	N/A	DWS Full Width?	N/A
N/A	Landing Curb? (Y/N)	N/A	N/A	DWS Offset (in)	N/A
N/A	Shared Landing?	N/A			
N/A	Gutter Ponding?	N/A	N/A	Gutter Slope (%)	N/A
N/A	Gutter Lip Ht (in)	1.0	N/A	Gutter X Slope (%)	N/A
N/A	Painted X Walk1?	No	N/A	Painted X Walk2?	No
	X Walk 1 Direction	To NW		X Walk 2 Direction	To SW
N/A	X Walk 1 Width (in)	N/A	N/A	X Walk 2 Width (in)	N/A
	X Walk 1 Slope (%)	5.3		X Walk 2 Slope (%)	4.8
	X Walk 1 X Slope (%)	2.6		X Walk 2 X Slope (%)	3.2
N/A	Ramp inside XWalk1?	N/A	N/A	Ramp inside XWalk2?	N/A

Road Slope (%)	3.2	N/A	Clear Space?	N/A
	Road X Slope (%)	6.8	N/A	Clear Space to XWalk (in)	N/A
N/A	Any Obstructions?	N/A	N/A	Storm Grate/Utility Hazard?	N/A
	Obstruction Type			Storm Grate/Utility Type	
		N/A			N/A
			Yes	Surface Condition? (G/P)	Good
			N/A	Curb Slope (%)	N/A

**Remove & Replace Curb Ramp With Two New Directional Ramps or Equivalent.**

**R304.3.2, R304.5.3**
