Access Compliance Report

Public Rights-of-Way

(Curb Ramps)

Intersection ID: 47968	Main Street: MESA_VERDE_RD	Cross Street: KYRENE_RD	Location: SE
ADA ID: A367AEB4DD76	Ramp Type: PerpDiag	Initial Pass/Fail: Fail	Overall Compliance: No
Severity Score: 21.25			
Codes/Mitigation Info/Possible Solution		Field Measurements/Component Compliance

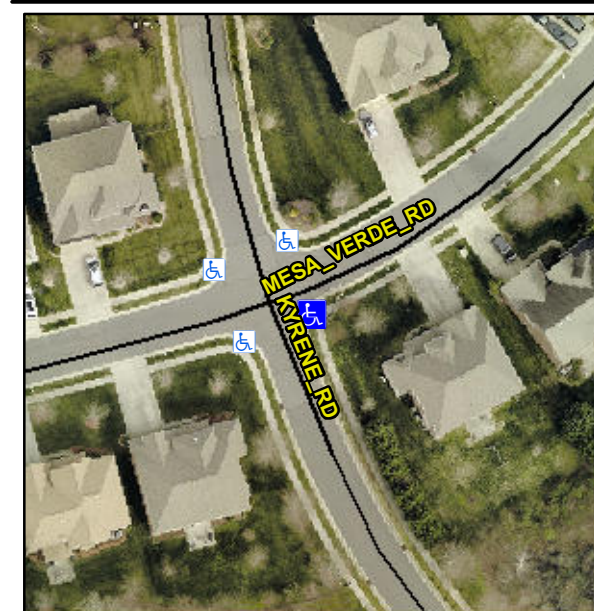
Not Found, R304.5.1, R304.2.2

Compliance	Description	Data	Compliance	Description	Data
N/A	Ramp Length (in)	48.0	No	Ramp Slope (%)	10.2
No	Ramp Width (in)	45.5	Yes	Ramp XSlope (%)	1.5
N/A	Flare Type LT	N/A	N/A	Flare Type RT	N/A
N/A	Flare Slope LT (%)	N/A	N/A	Flare Slope RT (%)	N/A
N/A	Flare Traversable LT?	N/A	N/A	Flare Traversable RT?	N/A
N/A	Landing Length (in)	N/A	N/A	DWS Provided?	N/A
N/A	Landing Width (in)	N/A	N/A	DWS Contrast?	N/A
N/A	Landing Slope (%)	N/A	N/A	DWS Length (in)	N/A
N/A	Landing X Slope (%)	N/A	N/A	DWS Full Width?	N/A
N/A	Landing Curb? (Y/N)	N/A	N/A	DWS Offset (in)	N/A
N/A	Shared Landing?	N/A			
N/A	Gutter Ponding?	N/A	N/A	Gutter Slope (%)	N/A
N/A	Gutter Lip Ht (in)	N/A	N/A	Gutter X Slope (%)	N/A
N/A	Painted X Walk1?	No	N/A	Painted X Walk2?	No
	X Walk 1 Direction	To N		X Walk 2 Direction	To W
N/A	X Walk 1 Width (in)	N/A	N/A	X Walk 2 Width (in)	N/A
	X Walk 1 Slope (%)	4.6		X Walk 2 Slope (%)	1.5
	X Walk 1 X Slope (%)	2.6		X Walk 2 X Slope (%)	5.0

N/A	Ramp inside XWalk1?	N/A	N/A	Ramp inside XWalk2?	N/A
	Road Slope (%)	5.5	N/A	Clear Space?	N/A
	Road X Slope (%)	2.1	N/A	Clear Space to XWalk (in)	N/A
N/A	Any Obstructions?	N/A	N/A	Storm Grate/Utility Hazard?	N/A
	Obstruction Type			Storm Grate/Utility Type	
		N/A			N/A
			Yes	Surface Condition? (G/P)	Good

Remove & Replace Curb Ramp With Two New Directional Ramps or Equivalent.
