Access Compliance Report

Public Rights-of-Way

(Curb Ramps)

Intersection ID: 10038352	Main Street: SOUTH_BV	Cross Street: N/A	Location: NE
ADA ID: A37240332817	Ramp Type: PerpDiag	Initial Pass/Fail: Fail	Overall Compliance: No
		Severity Score: 12.5

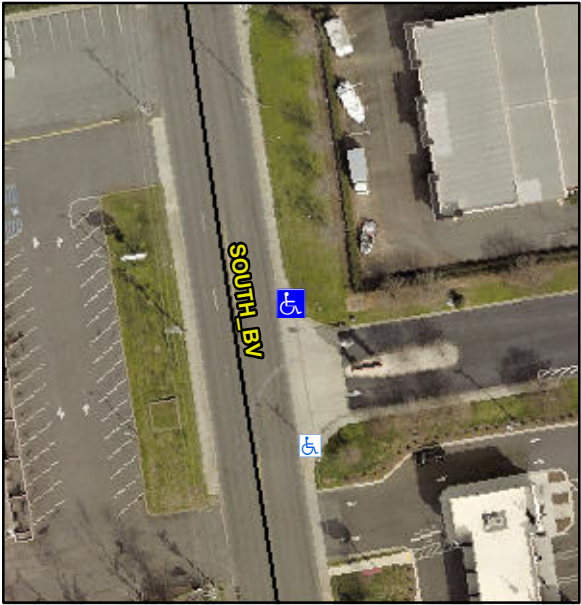
Possible Solutions:		Compliance	Description	Data
	Remove & Replace Curb Ramp With Two New Directional Ramps or Equivalent.		Yes	Ramp Length (in)	61.0
			N/A	Ramp Width (in)	58.0
			N/A	Flare Type LT	N/A
			N/A	Flare Slope LT (%)	N/A
			N/A	Flare Traversable LT?	N/A
			N/A	Landing Length (in)	N/A
			N/A	Landing Width (in)	N/A
			N/A	Landing Slope (%)	N/A
			N/A	Landing X Slope (%)	N/A
<p>Surveyor Notes:</p> <p>N/A</p> <p>PROW/ADA:</p> <p>Not Found, R304.5.3</p>			N/A	Flare Type RT	N/A
			N/A	Flare Slope RT (%)	N/A
			N/A	Flare Traversable RT?	N/A
			N/A	DWS Provided?	N/A
			N/A	DWS Contrast?	N/A
			N/A	DWS Length (in)	N/A
			N/A	DWS Full Width?	N/A
			N/A	DWS Offset (in)	N/A
			N/A	Gutter Ponding?	N/A
			N/A	Gutter Lip Ht (in)	N/A
			No	Painted X Walk1?	No
			To W	X Walk 1 Direction	To S
			N/A	X Walk 1 Width (in)	N/A

1.3	X Walk 1 Slope (%)	2.7
			0.2	X Walk 1 X Slope (%)	5.6
			N/A	Ramp inside XWalk1?	N/A
			0.0	Road Slope (%)	N/A
			1.8	Road X Slope (%)	N/A
			N/A	Any Obstructions?	N/A
				Obstruction Type	
Total Cost: \$ 3200.00			N/A	Storm Grate/Utility Hazard?	N/A
			N/A	Storm Grate/Utility Type	N/A
			Yes	Surface Condition? (G/P)	Good
