# Access Compliance Report

## Public Rights-of-Way (Curb Ramps)

Intersection ID: 50584	Main Street: GREAT_LAUREL_RD	Cross Street: GRAND_FIR_RD	Location: SE
ADA ID: A3799940B97A	Ramp Type: Perp	Initial Pass/Fail: Fail	Overall Compliance: No
Severity Score: 21.25			
Codes/Mitigation Info/Possible Solution		Field Measurements/Component Compliance

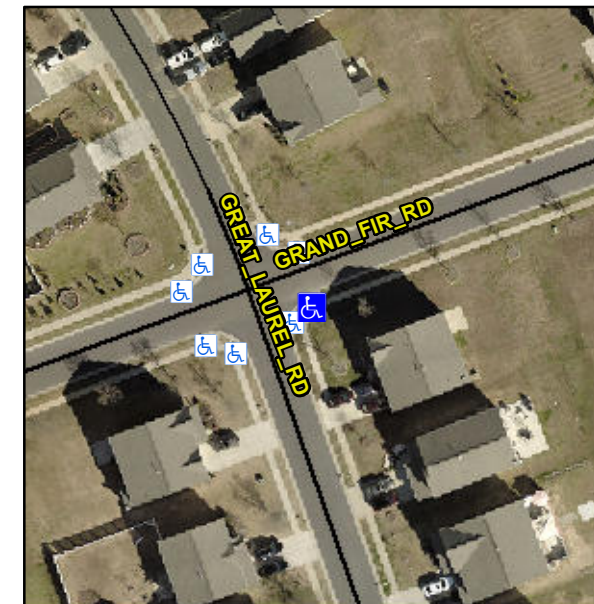
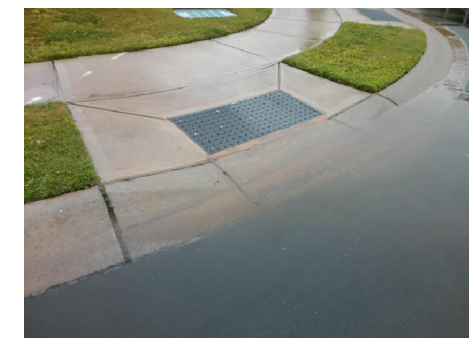
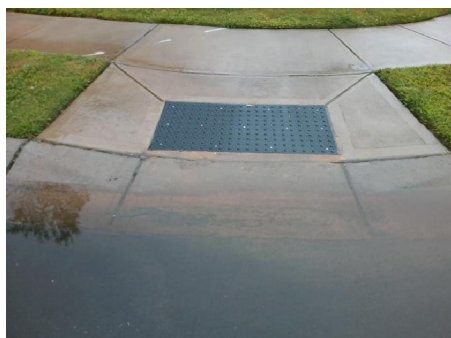
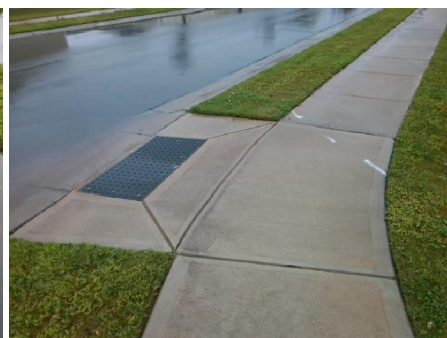
**Not Found, R304.5.1, R304.2.2**

Compliance	Description	Data	Compliance	Description	Data
N/A	Ramp Length (in)	46.5	No	Ramp Slope (%)	9.7
No	Ramp Width (in)	47.5	Yes	Ramp XSlope (%)	0.6
N/A	Flare Type LT	N/A	N/A	Flare Type RT	N/A
N/A	Flare Slope LT (%)	N/A	N/A	Flare Slope RT (%)	N/A
N/A	Flare Traversable LT?	N/A	N/A	Flare Traversable RT?	N/A
N/A	Landing Length (in)	N/A	N/A	DWS Provided?	N/A
N/A	Landing Width (in)	N/A	N/A	DWS Contrast?	N/A
N/A	Landing Slope (%)	N/A	N/A	DWS Length (in)	N/A
N/A	Landing X Slope (%)	N/A	N/A	DWS Full Width?	N/A
N/A	Landing Curb? (Y/N)	N/A	N/A	DWS Offset (in)	N/A
N/A	Shared Landing?	N/A			
N/A	Gutter Ponding?	Yes	N/A	Gutter Slope (%)	N/A
N/A	Gutter Lip Ht (in)	N/A	N/A	Gutter X Slope (%)	N/A
N/A	Painted X Walk1?	No	N/A	Painted X Walk2?	N/A
	X Walk 1 Direction	To N		X Walk 2 Direction	N/A
N/A	X Walk 1 Width (in)	N/A	N/A	X Walk 2 Width (in)	N/A
	X Walk 1 Slope (%)	2.8		X Walk 2 Slope (%)	N/A
	X Walk 1 X Slope (%)	1.1		X Walk 2 X Slope (%)	N/A

N/A	Ramp inside XWalk1?	N/A	N/A	Ramp inside XWalk2?	N/A
	Road Slope (%)	N/A	N/A	Clear Space?	N/A
	Road X Slope (%)	N/A	N/A	Clear Space to XWalk (in)	N/A
N/A	Any Obstructions?	N/A	N/A	Storm Grate/Utility Hazard?	N/A
	Obstruction Type			Storm Grate/Utility Type	
		N/A			N/A
			Yes	Surface Condition? (G/P)	Good

**Remove & Replace Entire Ramp.**
