# Access Compliance Report

## Public Rights-of-Way

### (Curb Ramps)

Intersection ID: 29978	Main Street: ALBANS_LN	Cross Street: BARVAS_ST	Location: SW
ADA ID: A37A057D752B	Ramp Type: PerpDiag	Initial Pass/Fail: Fail	Overall Compliance: No
Severity Score: 58.75			
Codes/Mitigation Info/Possible Solution		Field Measurements/Component Compliance

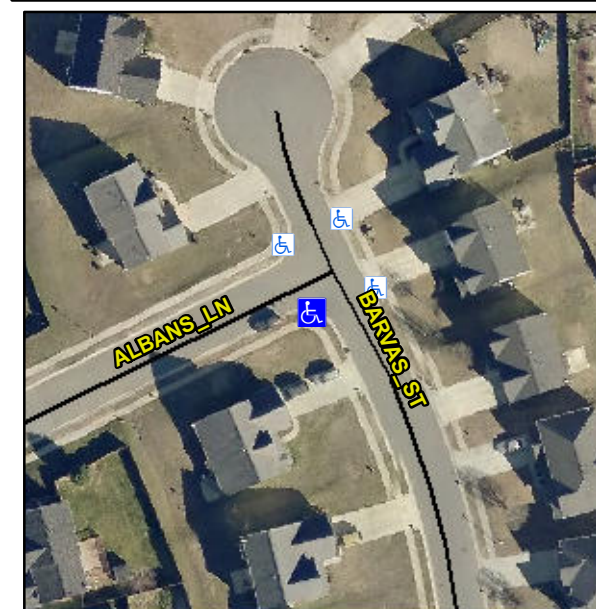
Compliance	Description	Data	Compliance	Description	Data
N/A	Ramp Length (in)	48.0	No	Ramp Slope (%)	13.2
No	Ramp Width (in)	47.0	No	Ramp XSlope (%)	9.7
N/A	Flare Type LT	N/A	N/A	Flare Type RT	N/A
N/A	Flare Slope LT (%)	N/A	N/A	Flare Slope RT (%)	N/A
N/A	Flare Traversable LT?	N/A	N/A	Flare Traversable RT?	N/A
N/A	Landing Length (in)	N/A	N/A	DWS Provided?	N/A
N/A	Landing Width (in)	N/A	N/A	DWS Contrast?	N/A
N/A	Landing Slope (%)	N/A	N/A	DWS Length (in)	N/A
N/A	Landing X Slope (%)	N/A	N/A	DWS Full Width?	N/A
N/A	Landing Curb? (Y/N)	N/A	N/A	DWS Offset (in)	N/A
N/A	Shared Landing?	N/A			
N/A	Gutter Ponding?	N/A	N/A	Gutter Slope (%)	N/A
N/A	Gutter Lip Ht (in)	N/A	N/A	Gutter X Slope (%)	N/A
N/A	Painted X Walk1?	No	N/A	Painted X Walk2?	No
	X Walk 1 Direction	To E		X Walk 2 Direction	To N
N/A	X Walk 1 Width (in)	N/A	N/A	X Walk 2 Width (in)	N/A
	X Walk 1 Slope (%)	1.3		X Walk 2 Slope (%)	1.8
	X Walk 1 X Slope (%)	3.2		X Walk 2 X Slope (%)	6.2

N/A	Ramp inside XWalk1?	N/A	N/A	Ramp inside XWalk2?	N/A
	Road Slope (%)	7.1	N/A	Clear Space?	N/A
	Road X Slope (%)	2.2	N/A	Clear Space to XWalk (in)	N/A
N/A	Any Obstructions?	N/A	N/A	Storm Grate/Utility Hazard?	N/A
	Obstruction Type			Storm Grate/Utility Type	
		N/A			N/A
		Yes		Surface Condition? (G/P)	Good

**Remove & Replace Curb Ramp With Two New Directional Ramps or Equivalent.**

**R304.5.1, R304.2.2, R304.5.3**
