# Access Compliance Report

## Public Rights-of-Way

### (Curb Ramps)

Intersection ID: 50588	Main Street: BENDING_BRANCH_RD	Cross Street: DOWNY_BIRCH_RD	Location: NW
ADA ID: A37A8736B51C	Ramp Type: Perp	Initial Pass/Fail: Fail	Overall Compliance: No
Severity Score: 8.75			
Codes/Mitigation Info/Possible Solution		Field Measurements/Component Compliance

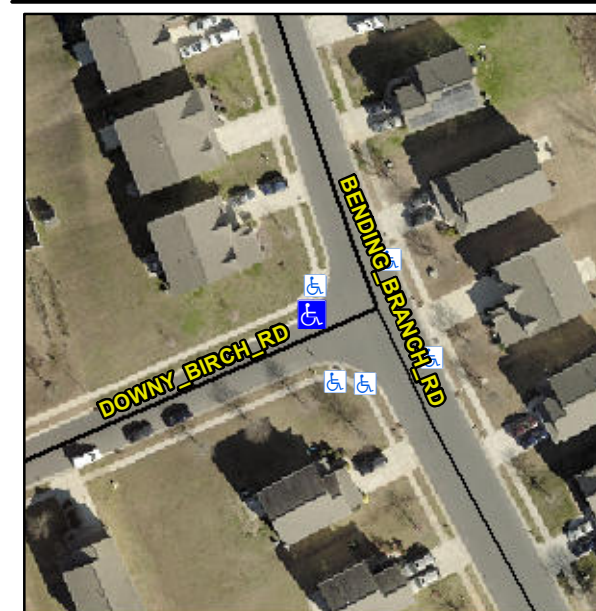
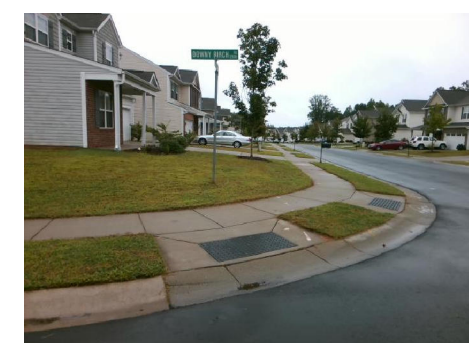
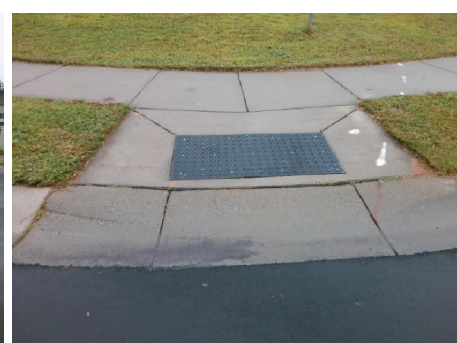
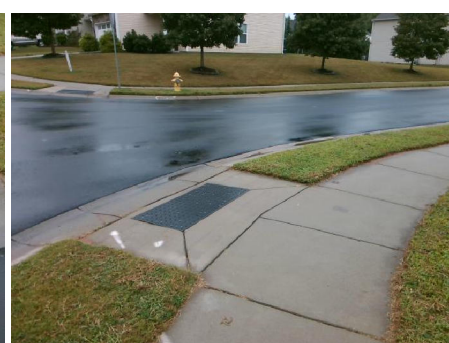
Compliance	Description	Data	Compliance	Description	Data
N/A	Ramp Length (in)	48.5	Yes	Ramp Slope (%)	7.4
No	Ramp Width (in)	47.5	Yes	Ramp XSlope (%)	1.0
N/A	Flare Type LT	N/A	N/A	Flare Type RT	N/A
N/A	Flare Slope LT (%)	N/A	N/A	Flare Slope RT (%)	N/A
N/A	Flare Traversable LT?	N/A	N/A	Flare Traversable RT?	N/A
N/A	Landing Length (in)	N/A	N/A	DWS Provided?	N/A
N/A	Landing Width (in)	N/A	N/A	DWS Contrast?	N/A
N/A	Landing Slope (%)	N/A	N/A	DWS Length (in)	N/A
N/A	Landing X Slope (%)	N/A	N/A	DWS Full Width?	N/A
N/A	Landing Curb? (Y/N)	N/A	N/A	DWS Offset (in)	N/A
N/A	Shared Landing?	N/A			
N/A	Gutter Ponding?	N/A	N/A	Gutter Slope (%)	N/A
N/A	Gutter Lip Ht (in)	N/A	N/A	Gutter X Slope (%)	N/A
N/A	Painted X Walk1?	No	N/A	Painted X Walk2?	N/A
	X Walk 1 Direction	To S		X Walk 2 Direction	N/A
N/A	X Walk 1 Width (in)	N/A	N/A	X Walk 2 Width (in)	N/A
	X Walk 1 Slope (%)	2.6		X Walk 2 Slope (%)	N/A
	X Walk 1 X Slope (%)	1.4		X Walk 2 X Slope (%)	N/A

N/A	Ramp inside XWalk1?	N/A	N/A	Ramp inside XWalk2?	N/A
	Road Slope (%)	N/A	N/A	Clear Space?	N/A
	Road X Slope (%)	N/A	N/A	Clear Space to XWalk (in)	N/A
N/A	Any Obstructions?	N/A	N/A	Storm Grate/Utility Hazard?	N/A
	Obstruction Type			Storm Grate/Utility Type	
		N/A			N/A
			Yes	Surface Condition? (G/P)	Good

**Remove & Replace Entire Ramp.**

Total Cost: \$ 1850.00
