## Access Compliance Report Public Rights-of-Way (Curb Ramps)

Intersection ID: N/A Main Street: PINEVILLE-MATTHEWS RD Cross Street: N/A Location: SE									
Intersection ID: N/A Main Street: PINEVILLE-MATTHEWS_RD								Location:	SE
ADA ID: A38CD855EF0B Ramp Type: PerpDiag			Initial I	nitial Pass/Fail: Fail Overall Compliance: No				o Severity Score:	13.75
Codes/Mitigation Info/Possible Solution				Field Measurements/Component Compliance

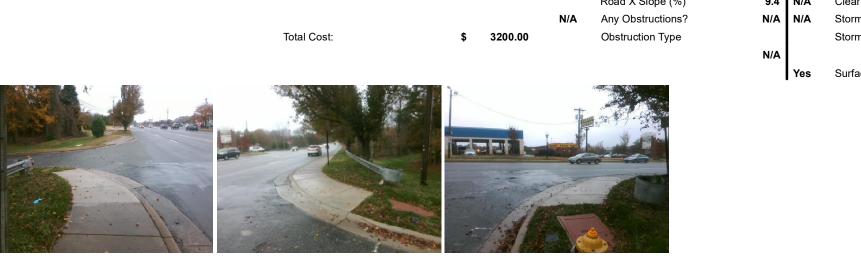
E. P. CHARLES ESDER	Possible Solutions:		Compliance Description Da		Data	a Compliance Description		Data
		Remove & Replace Curb Ramp	With	N/A	Ramp Length (in)	63.0	No	Ramp Slope (%)	9.0
March Real		Two New Directional Ramps or		Yes	Ramp Width (in)	48.0	No	Ramp XSlope (%)	4.0
		È Equivalent.		N/A	Flare Type LT	N/A	N/A	Flare Type RT	N/A
1 Leans				N/A	Flare Slope LT (%)	N/A	N/A	Flare Slope RT (%)	N/A
	EMAITCHENS RD			N/A	Flare Traversable LT?	N/A	N/A	Flare Traversable RT?	N/A
DINEVILLE	MATOME			N/A	Landing Length (in)	N/A	N/A	DWS Provided?	N/A

- in the second second	Martin Martine	Surveyor Notes:		N/A	Landing Width (in)	N/A	N/A	DWS Contrast?	N/A
	E. States	N/A		N/A	Landing Slope (%)	N/A	N/A	DWS Length (in)	N/A
PROW/ADA: Not Found, R304.2.2, R304.5.3				N/A	Landing X Slope (%)	N/A	N/A	DWS Full Width?	N/A
				N/A	Landing Curb? (Y/N)	N/A	N/A	DWS Offset (in)	N/A
				N/A	Shared Landing?	N/A			
				N/A	Gutter Ponding?	N/A	N/A	Gutter Slope (%)	N/A
				N/A	Gutter Lip Ht (in)	N/A	N/A	Gutter X Slope (%)	N/A
				N/A	Painted X Walk1?	No	N/A	Painted X Walk2?	No
					X Walk 1 Direction	To N		X Walk 2 Direction	To W
				N/A	X Walk 1 Width (in)	N/A	N/A	X Walk 2 Width (in)	N/A
Street 1 Name	PINEVILLE-MATTHEWS RD	_			X Walk 1 Slope (%)	7.7		X Walk 2 Slope (%)	3.7
Stop Condition-Street 2	None				X Walk 1 X Slope (%)	5.7		X Walk 2 X Slope (%)	10.3
Street 2 Name	ENTRANCE			N/A	Ramp inside XWalk1?	N/A	N/A	Ramp inside XWalk2?	N/A
Stop Condition-Street 1	StopSign				Road Slope (%)	6.8	N/A	Clear Space?	N/A

Road X Slope (%)	9.4	N/A	Clear Space to XWalk (in)	N/A
				N/A	Any Obstructions?	N/A	N/A	Storm Grate/Utility Hazard?	N/A
		Total Cost: \$	3200.00		Obstruction Type			Storm Grate/Utility Type	
					<i>.</i>	N/A		5 51	N/A
