Access Compliance Report

Public Rights-of-Way

(Curb Ramps)

Intersection ID: 14253	Main Street: LUTHER_ST	Cross Street: S_TORRENCE_ST	Location: W
ADA ID: A38EA0D02B25	Ramp Type: PerpDiag	Initial Pass/Fail: Fail	Overall Compliance: No
		Severity Score: 1.25

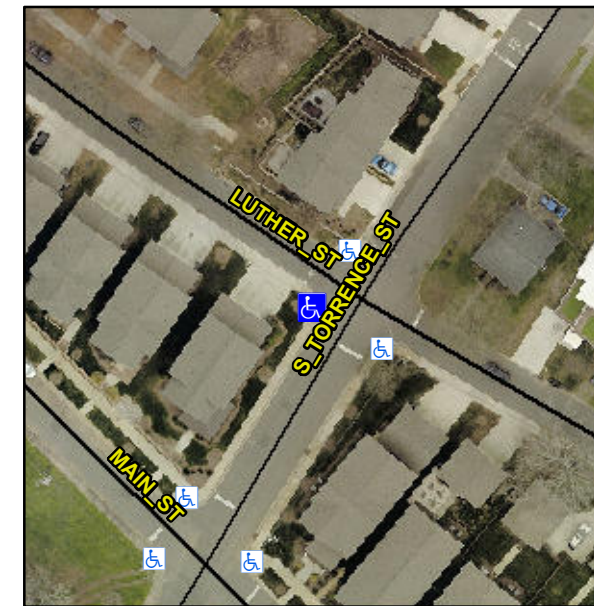
Not Found, R304.5.3

Compliance	Description	Data	Compliance	Description	Data
N/A	Ramp Length (in)	52.0	Yes	Ramp Slope (%)	8.1
Yes	Ramp Width (in)	48.0	No	Ramp XSlope (%)	3.4
N/A	Flare Type LT	N/A	N/A	Flare Type RT	N/A
N/A	Flare Slope LT (%)	N/A	N/A	Flare Slope RT (%)	N/A
N/A	Flare Traversable LT?	N/A	N/A	Flare Traversable RT?	N/A
N/A	Landing Length (in)	N/A	N/A	DWS Provided?	N/A
N/A	Landing Width (in)	N/A	N/A	DWS Contrast?	N/A
N/A	Landing Slope (%)	N/A	N/A	DWS Length (in)	N/A
N/A	Landing X Slope (%)	N/A	N/A	DWS Full Width?	N/A
N/A	Landing Curb? (Y/N)	N/A	N/A	DWS Offset (in)	N/A
N/A	Shared Landing?	N/A			
N/A	Gutter Ponding?	N/A	N/A	Gutter Slope (%)	N/A
N/A	Gutter Lip Ht (in)	N/A	N/A	Gutter X Slope (%)	N/A
N/A	Painted X Walk1?	No	N/A	Painted X Walk2?	No
	X Walk 1 Direction	To SE		X Walk 2 Direction	To NE
N/A	X Walk 1 Width (in)	N/A	N/A	X Walk 2 Width (in)	N/A
	X Walk 1 Slope (%)	9.0		X Walk 2 Slope (%)	11.1
	X Walk 1 X Slope (%)	6.2		X Walk 2 X Slope (%)	4.7

N/A	Ramp inside XWalk1?	N/A	N/A	Ramp inside XWalk2?	N/A
	Road Slope (%)	2.8	N/A	Clear Space?	N/A
	Road X Slope (%)	10.9	N/A	Clear Space to XWalk (in)	N/A
N/A	Any Obstructions?	N/A	N/A	Storm Grate/Utility Hazard?	N/A
	Obstruction Type			Storm Grate/Utility Type	
		N/A			N/A
			Yes	Surface Condition? (G/P)	Good

Remove & Replace Curb Ramp With Two New Directional Ramps or Equivalent.

Total Cost: \$ 3200.00
