Access Compliance Report

Public Rights-of-Way

(Curb Ramps)

Intersection ID: 50341	Main Street: SCONE_PALACE_CT	Cross Street: CASTLECOVE_RD	Location: NW
ADA ID: A38F36A88A02	Ramp Type: Perp	Initial Pass/Fail: Fail	Overall Compliance: No
Severity Score: 8.75			
Codes/Mitigation Info/Possible Solution		Field Measurements/Component Compliance

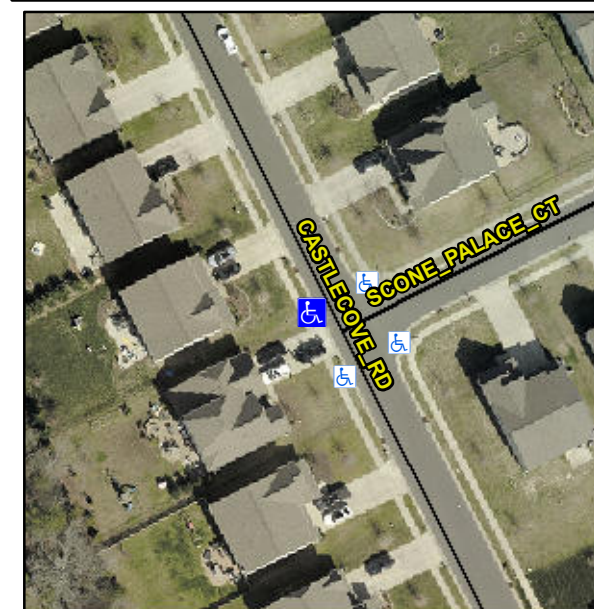
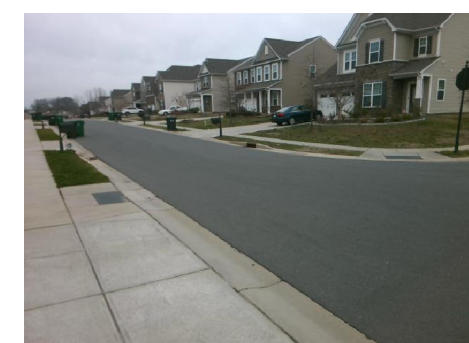
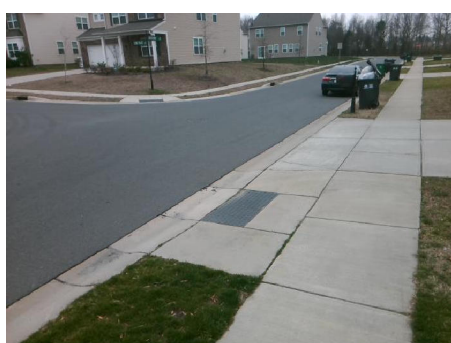
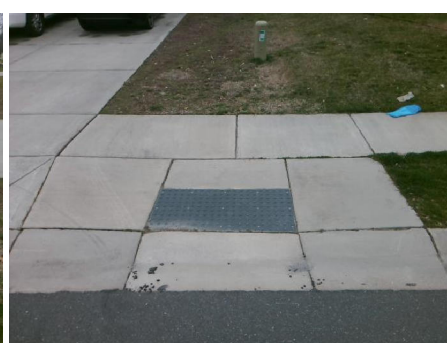
Not Found, R304.5.1

Compliance	Description	Data	Compliance	Description	Data
N/A	Ramp Length (in)	47.0	Yes	Ramp Slope (%)	5.1
No	Ramp Width (in)	47.0	Yes	Ramp XSlope (%)	1.9
N/A	Flare Type LT	N/A	N/A	Flare Type RT	N/A
N/A	Flare Slope LT (%)	N/A	N/A	Flare Slope RT (%)	N/A
N/A	Flare Traversable LT?	N/A	N/A	Flare Traversable RT?	N/A
N/A	Landing Length (in)	N/A	N/A	DWS Provided?	N/A
N/A	Landing Width (in)	N/A	N/A	DWS Contrast?	N/A
N/A	Landing Slope (%)	N/A	N/A	DWS Length (in)	N/A
N/A	Landing X Slope (%)	N/A	N/A	DWS Full Width?	N/A
N/A	Landing Curb? (Y/N)	N/A	N/A	DWS Offset (in)	N/A
N/A	Shared Landing?	N/A			
N/A	Gutter Ponding?	N/A	N/A	Gutter Slope (%)	N/A
N/A	Gutter Lip Ht (in)	N/A	N/A	Gutter X Slope (%)	N/A
N/A	Painted X Walk1?	No	N/A	Painted X Walk2?	N/A
	X Walk 1 Direction	To NE		X Walk 2 Direction	N/A
N/A	X Walk 1 Width (in)	N/A	N/A	X Walk 2 Width (in)	N/A
	X Walk 1 Slope (%)	1.3		X Walk 2 Slope (%)	N/A
	X Walk 1 X Slope (%)	1.5		X Walk 2 X Slope (%)	N/A

N/A	Ramp inside XWalk1?	N/A	N/A	Ramp inside XWalk2?	N/A
	Road Slope (%)	N/A	N/A	Clear Space?	N/A
	Road X Slope (%)	N/A	N/A	Clear Space to XWalk (in)	N/A
N/A	Any Obstructions?	N/A	N/A	Storm Grate/Utility Hazard?	N/A
	Obstruction Type			Storm Grate/Utility Type	
		N/A			N/A
			Yes	Surface Condition? (G/P)	Good

Remove & Replace Entire Ramp.
