Access Compliance Report

Public Rights-of-Way

(Curb Ramps)

Intersection ID: 14366	Main Street: E_KINGSTON_AV	Cross Street: WINTHROP_AV	Location: S
ADA ID: A38FCB65457C	Ramp Type: Perp	Initial Pass/Fail: Pass	Overall Compliance: No
Codes/Mitigation Info/Possible Solution		Field Measurements/Component Compliance	
Severity Score: 25.25

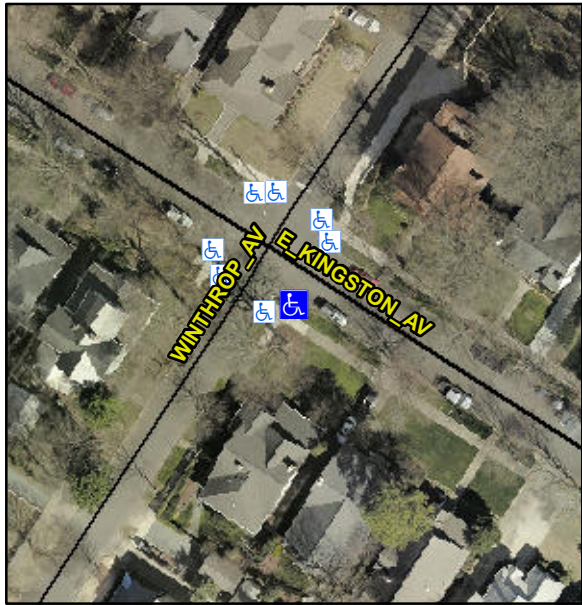
Compliance	Description	Data	Compliance	Description	Data
N/A	Ramp Length (in)	89.0	Yes	Ramp Slope (%)	7.4
Yes	Ramp Width (in)	48.0	No	Ramp XSlope (%)	3.5
N/A	Flare Type LT	Sloped	N/A	Flare Type RT	N/A
N/A	Flare Slope LT (%)	12.1	N/A	Flare Slope RT (%)	14.6
N/A	Flare Traversable LT?	No	N/A	Flare Traversable RT?	No
Yes	Landing Length (in)	70.0	No	DWS Provided?	No
Yes	Landing Width (in)	58.0	N/A	DWS Contrast?	No
No	Landing Slope (%)	4.1	N/A	DWS Length (in)	N/A
Yes	Landing X Slope (%)	1.5	N/A	DWS Full Width?	No
N/A	Landing Curb? (Y/N)	No	N/A	DWS Offset (in)	N/A
N/A	Shared Landing?	No			
No	Gutter Ponding?	Yes	Yes	Gutter Slope (%)	4.0
No	Gutter Lip Ht (in)	1.0	Yes	Gutter X Slope (%)	0.4
N/A	Painted X Walk1?	No	N/A	Painted X Walk2?	N/A
	X Walk 1 Direction	To NE		X Walk 2 Direction	N/A
N/A	X Walk 1 Width (in)	N/A	N/A	X Walk 2 Width (in)	N/A
	X Walk 1 Slope (%)	4.0		X Walk 2 Slope (%)	N/A
	X Walk 1 X Slope (%)	1.5		X Walk 2 X Slope (%)	N/A

N/A	Ramp inside XWalk1?	N/A	N/A	Ramp inside XWalk2?	N/A
	Road Slope (%)	N/A	N/A	Clear Space?	Yes
	Road X Slope (%)	N/A	N/A	Clear Space to XWalk (in)	N/A
Yes	Any Obstructions?	No	Yes	Storm Grate/Utility Hazard?	No
	Obstruction Type			Storm Grate/Utility Type	
		N/A			N/A
			Yes	Surface Condition? (G/P)	Good

Possible Solutions:				
	Remove & Replace Entire Ramp. Grind Gutter Lip.				
	Surveyor Notes:				
	N/A				
	PROW/ADA:				
	R304.5.3, R304.2.2-Perp, R304.3.2- Para, R305, R302.7, R302.7.2				
	Street 1 Name		E KINGSTON AV		
	Stop Condition-Street 2		None		
	Street 2 Name		N/A		
	Stop Condition-Street 1		N/A		
Total Cost:		\$	2050.00
