Access Compliance Report

Public Rights-of-Way

(Curb Ramps)

| Intersection ID: 10014519 | Main Street: UNIVERSITY_POINTE_BV | Cross Street: N/A | Location: NW |

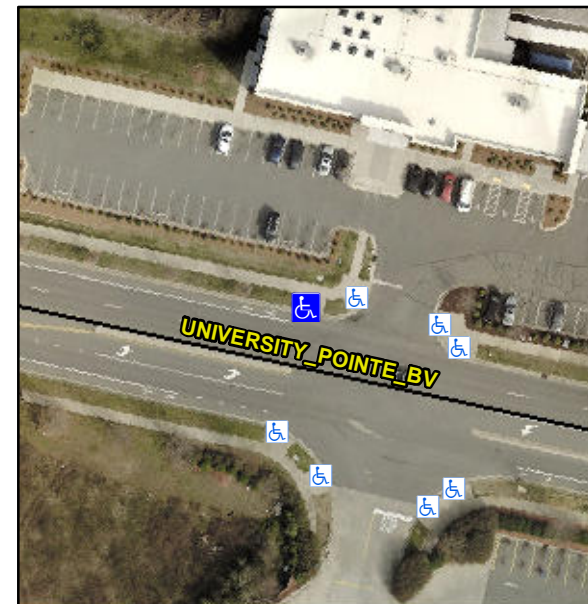
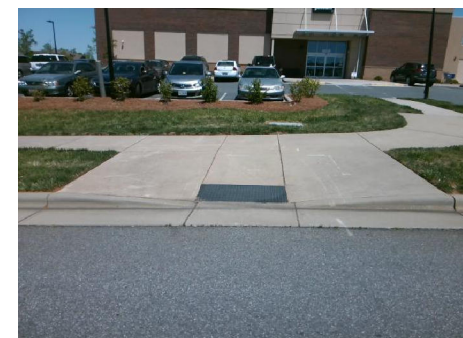
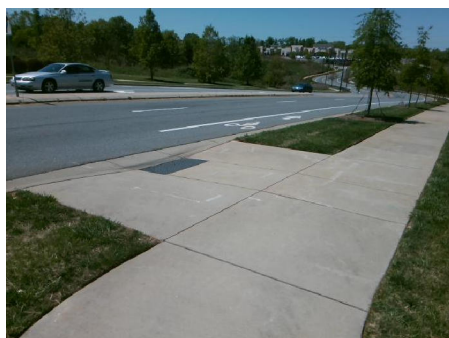
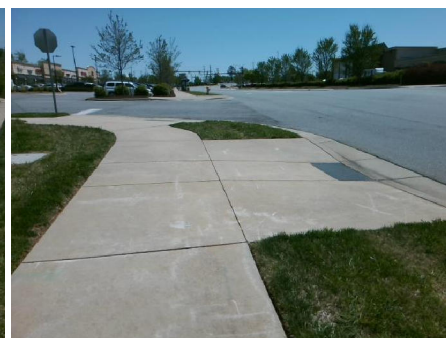
| ADA ID: A39078F48F70 | Ramp Type: Perp | Initial Pass/Fail: Fail | Overall Compliance: No |
| Severity Score: 22.5 | | | |

R304.5.1, R304.2.2

| Compliance | Description | Data | Compliance | Description | Data |
|---|---|---|---|---|---|
| N/A | Ramp Length (in) | 96.0 | No | Ramp Slope (%) | 8.4 |
| No | Ramp Width (in) | 47.0 | Yes | Ramp XSlope (%) | 4.9 |

Remove & Replace Entire Ramp.
