Access Compliance Report

Public Rights-of-Way

(Curb Ramps)

Intersection ID: 16415	Main Street: BEVERLY_DR	Cross Street: SHERWOOD_AV	Location: S
ADA ID: A3A2EE955257	Ramp Type: PerpDiag	Initial Pass/Fail: Fail	Overall Compliance: No
		Severity Score: 13.75

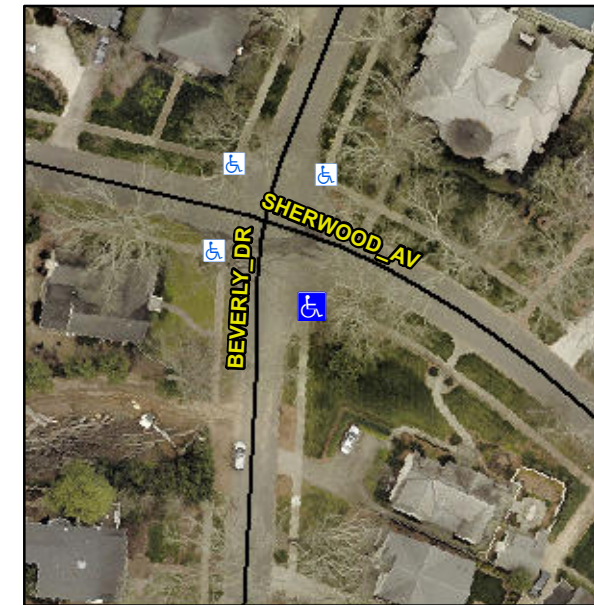
Not Found, R304.2.2, R304.5.3

Compliance	Description	Data	Compliance	Description	Data
N/A	Ramp Length (in)	53.0	No	Ramp Slope (%)	10.8
Yes	Ramp Width (in)	120.0	No	Ramp XSlope (%)	2.9
N/A	Flare Type LT	N/A	N/A	Flare Type RT	N/A
N/A	Flare Slope LT (%)	N/A	N/A	Flare Slope RT (%)	N/A
N/A	Flare Traversable LT?	N/A	N/A	Flare Traversable RT?	N/A
N/A	Landing Length (in)	N/A	N/A	DWS Provided?	N/A
N/A	Landing Width (in)	N/A	N/A	DWS Contrast?	N/A
N/A	Landing Slope (%)	N/A	N/A	DWS Length (in)	N/A
N/A	Landing X Slope (%)	N/A	N/A	DWS Full Width?	N/A
N/A	Landing Curb? (Y/N)	N/A	N/A	DWS Offset (in)	N/A
N/A	Shared Landing?	N/A			
N/A	Gutter Ponding?	N/A	N/A	Gutter Slope (%)	N/A
N/A	Gutter Lip Ht (in)	N/A	N/A	Gutter X Slope (%)	N/A
N/A	Painted X Walk1?	No	N/A	Painted X Walk2?	No
	X Walk 1 Direction	To NE		X Walk 2 Direction	To NW
N/A	X Walk 1 Width (in)	N/A	N/A	X Walk 2 Width (in)	N/A
	X Walk 1 Slope (%)	1.1		X Walk 2 Slope (%)	5.0
	X Walk 1 X Slope (%)	2.8		X Walk 2 X Slope (%)	1.8

N/A	Ramp inside XWalk1?	N/A	N/A	Ramp inside XWalk2?	N/A
	Road Slope (%)	3.3	N/A	Clear Space?	N/A
	Road X Slope (%)	3.2	N/A	Clear Space to XWalk (in)	N/A
N/A	Any Obstructions?	N/A	N/A	Storm Grate/Utility Hazard?	N/A
	Obstruction Type			Storm Grate/Utility Type	
		N/A			N/A
			Yes	Surface Condition? (G/P)	Good

Remove & Replace Curb Ramp With Two New Directional Ramps or Equivalent.
