# Access Compliance Report

## Public Rights-of-Way

### (Curb Ramps)

Intersection ID: 10035338	Main Street: RAIL_CROSSING_LN	Cross Street: N/A	Location: NE
ADA ID: A3A8591EBE23	Ramp Type: Perp	Initial Pass/Fail: Fail	Overall Compliance: No
Severity Score: 13.75			
Codes/Mitigation Info/Possible Solution		Field Measurements/Component Compliance

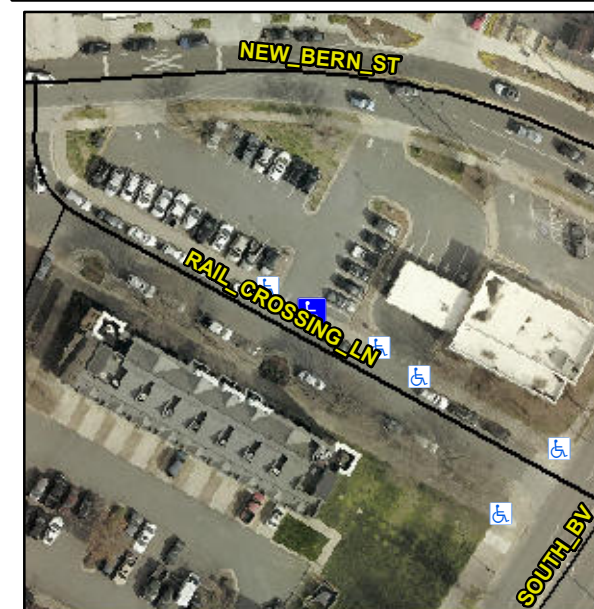
Compliance	Description	Data	Compliance	Description	Data
N/A	Ramp Length (in)	63.0	No	Ramp Slope (%)	9.3
Yes	Ramp Width (in)	63.0	Yes	Ramp XSlope (%)	5.0
N/A	Flare Type LT	N/A	N/A	Flare Type RT	N/A
N/A	Flare Slope LT (%)	N/A	N/A	Flare Slope RT (%)	N/A
N/A	Flare Traversable LT?	N/A	N/A	Flare Traversable RT?	N/A
N/A	Landing Length (in)	N/A	N/A	DWS Provided?	N/A
N/A	Landing Width (in)	N/A	N/A	DWS Contrast?	N/A
N/A	Landing Slope (%)	N/A	N/A	DWS Length (in)	N/A
N/A	Landing X Slope (%)	N/A	N/A	DWS Full Width?	N/A
N/A	Landing Curb? (Y/N)	N/A	N/A	DWS Offset (in)	N/A
N/A	Shared Landing?	N/A			
N/A	Gutter Ponding?	N/A	N/A	Gutter Slope (%)	N/A
N/A	Gutter Lip Ht (in)	N/A	N/A	Gutter X Slope (%)	N/A
N/A	Painted X Walk1?	No	N/A	Painted X Walk2?	N/A
	X Walk 1 Direction	To NW		X Walk 2 Direction	N/A
N/A	X Walk 1 Width (in)	N/A	N/A	X Walk 2 Width (in)	N/A
	X Walk 1 Slope (%)	2.4		X Walk 2 Slope (%)	N/A
	X Walk 1 X Slope (%)	5.0		X Walk 2 X Slope (%)	N/A

N/A	Ramp inside XWalk1?	N/A	N/A	Ramp inside XWalk2?	N/A
	Road Slope (%)	N/A	N/A	Clear Space?	N/A
	Road X Slope (%)	N/A	N/A	Clear Space to XWalk (in)	N/A
N/A	Any Obstructions?	N/A	N/A	Storm Grate/Utility Hazard?	N/A
	Obstruction Type			Storm Grate/Utility Type	
		N/A			N/A
		Yes		Surface Condition? (G/P)	Good

Possible Solutions:

**Remove & Replace Entire Ramp.**

**Not Found, R304.2.2**
