Access Compliance Report

Public Rights-of-Way

(Curb Ramps)

Intersection ID: 50591	Main Street: GREEN_GRASS_RD	Cross Street: LONGSTRAW_RD	Location: NW
ADA ID: A3AA29CCE73F	Ramp Type: Perp	Initial Pass/Fail: Fail	Overall Compliance: No
		Severity Score: 35

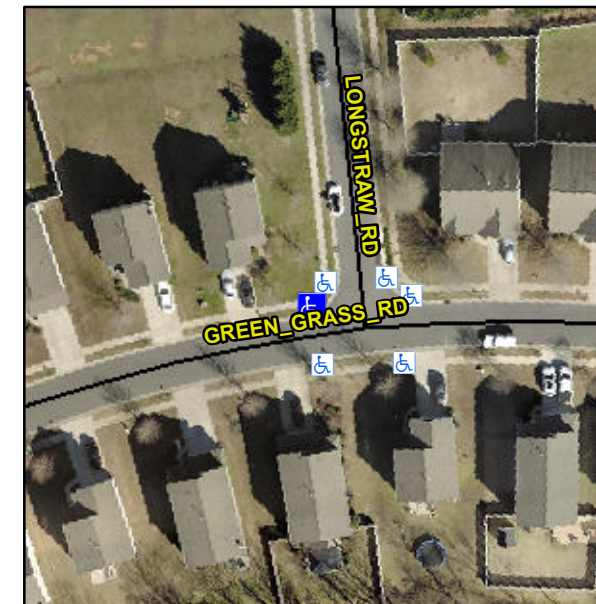
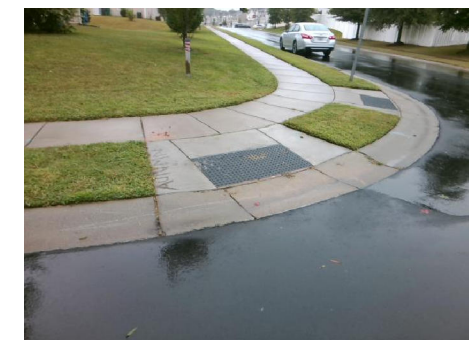
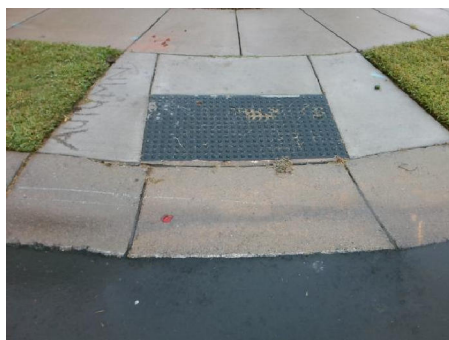
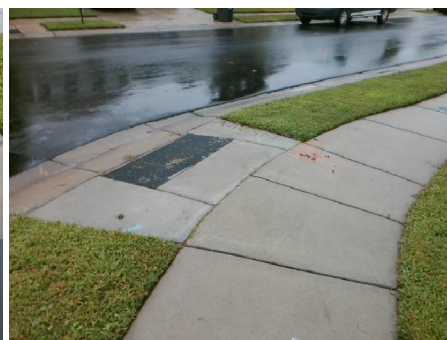
Not Found, R304.5.1, R304.2.2

Compliance	Description	Data	Compliance	Description	Data
N/A	Ramp Length (in)	49.5	No	Ramp Slope (%)	14.0
No	Ramp Width (in)	47.0	Yes	Ramp XSlope (%)	2.7
N/A	Flare Type LT	N/A	N/A	Flare Type RT	N/A
N/A	Flare Slope LT (%)	N/A	N/A	Flare Slope RT (%)	N/A
N/A	Flare Traversable LT?	N/A	N/A	Flare Traversable RT?	N/A
N/A	Landing Length (in)	N/A	N/A	DWS Provided?	N/A
N/A	Landing Width (in)	N/A	N/A	DWS Contrast?	N/A
N/A	Landing Slope (%)	N/A	N/A	DWS Length (in)	N/A
N/A	Landing X Slope (%)	N/A	N/A	DWS Full Width?	N/A
N/A	Landing Curb? (Y/N)	N/A	N/A	DWS Offset (in)	N/A
N/A	Shared Landing?	N/A			
N/A	Gutter Ponding?	N/A	N/A	Gutter Slope (%)	N/A
N/A	Gutter Lip Ht (in)	N/A	N/A	Gutter X Slope (%)	N/A
N/A	Painted X Walk1?	No	N/A	Painted X Walk2?	N/A
	X Walk 1 Direction	To S		X Walk 2 Direction	N/A
N/A	X Walk 1 Width (in)	N/A	N/A	X Walk 2 Width (in)	N/A
	X Walk 1 Slope (%)	2.3		X Walk 2 Slope (%)	N/A
	X Walk 1 X Slope (%)	4.6		X Walk 2 X Slope (%)	N/A

N/A	Ramp inside XWalk1?	N/A	N/A	Ramp inside XWalk2?	N/A
	Road Slope (%)	N/A	N/A	Clear Space?	N/A
	Road X Slope (%)	N/A	N/A	Clear Space to XWalk (in)	N/A
N/A	Any Obstructions?	N/A	N/A	Storm Grate/Utility Hazard?	N/A
	Obstruction Type			Storm Grate/Utility Type	
		N/A			N/A
			Yes	Surface Condition? (G/P)	Good

Remove & Replace Entire Ramp.
