Access Compliance Report

Public Rights-of-Way

(Curb Ramps)

Intersection ID: 31352	Main Street: MCINTYRE_RIDGE_DR	Cross Street: TRULL_ST	Location: SE
ADA ID: A3B563D058BF	Ramp Type: BlendTrans1	Initial Pass/Fail: Fail	Overall Compliance: No
			Severity Score: 33.75

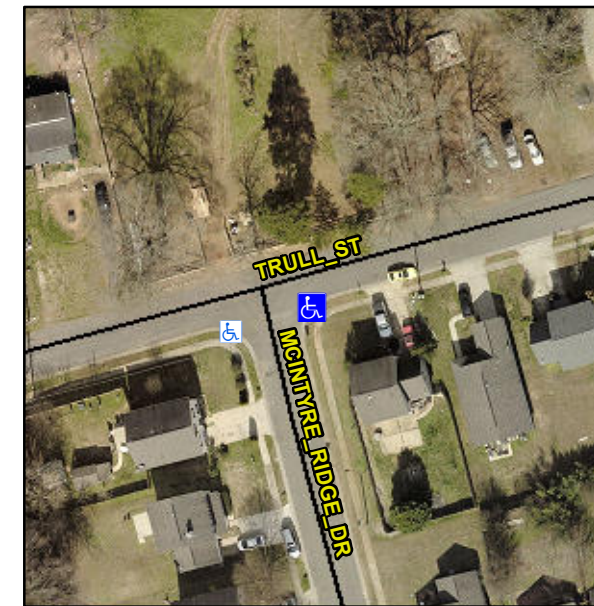
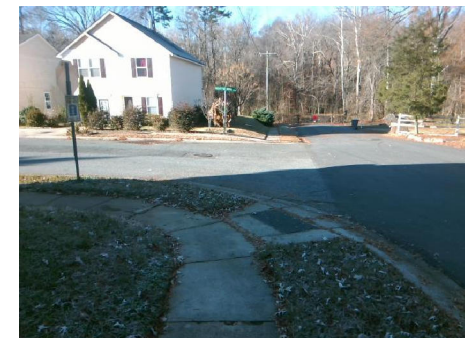
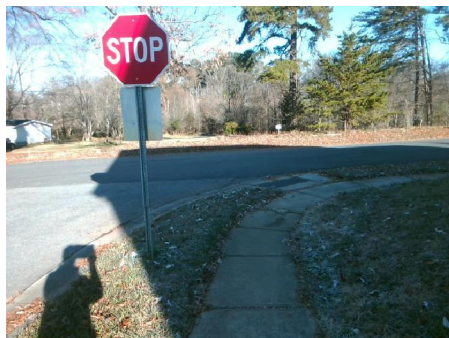
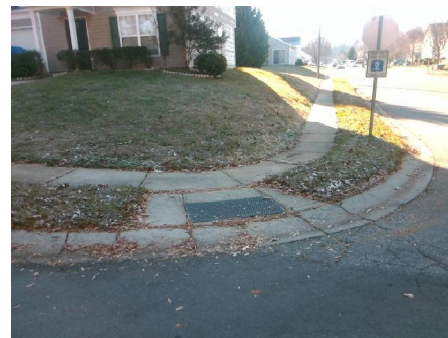
Not Found, R304.5.1, R304.5.3

Compliance	Description	Data	Compliance	Description	Data
N/A	Ramp Length (in)	43.5	Yes	BlendTrans Slope (%)	2.5
No	Ramp Width (in)	43.0	No	BlendTrans XSlope (%)	7.7
N/A	Flare Type LT	N/A	N/A	Flare Type RT	N/A
N/A	Flare Slope LT (%)	N/A	N/A	Flare Slope RT (%)	N/A
N/A	Flare Traversable LT?	N/A	N/A	Flare Traversable RT?	N/A
N/A	Landing Length (in)	N/A	N/A	DWS Provided?	N/A
N/A	Landing Width (in)	N/A	N/A	DWS Contrast?	N/A
N/A	Landing Slope (%)	N/A	N/A	DWS Length (in)	N/A
N/A	Landing X Slope (%)	N/A	N/A	DWS Full Width?	N/A
N/A	Landing Curb? (Y/N)	N/A	N/A	DWS Offset (in)	N/A
N/A	Shared Landing?	N/A			
N/A	Gutter Ponding?	N/A	N/A	Gutter Slope (%)	N/A
N/A	Gutter Lip Ht (in)	N/A	N/A	Gutter X Slope (%)	N/A
N/A	Painted X Walk1?	No	N/A	Painted X Walk2?	N/A
	X Walk 1 Direction	To W		X Walk 2 Direction	N/A
	X Walk 1 Width (in)	N/A		X Walk 2 Width (in)	N/A
	X Walk 1 Slope (%)	5.5		X Walk 2 Slope (%)	N/A
	X Walk 1 X Slope (%)	3.2		X Walk 2 X Slope (%)	N/A

N/A	Ramp inside XWalk1?	N/A	N/A	Ramp inside XWalk2?	N/A
	Road Slope (%)	3.2		Clear Space?	N/A
	Road X Slope (%)	5.5	N/A	Clear Space to XWalk (in)	N/A
N/A	Any Obstructions?	N/A	N/A	Storm Grate/Utility Hazard?	N/A
	Obstruction Type			Storm Grate/Utility Type	
		N/A			N/A
			Yes	Surface Condition? (G/P)	Good
			No	Curb Slope (%)	12.0

Remove & Replace Curb Ramp With Two New Directional Ramps or Equivalent.
