Access Compliance Report

Public Rights-of-Way

(Curb Ramps)

Intersection ID: 53286	Main Street: PROSPERITY_CHURCH_RD	Cross Street: CRAVEN_THOMAS_RD	Location: W
ADA ID: A3B5B8D1984E	Ramp Type: Perp	Initial Pass/Fail: Fail	Overall Compliance: No
Severity Score: 13.75			
Codes/Mitigation Info/Possible Solution		Field Measurements/Component Compliance

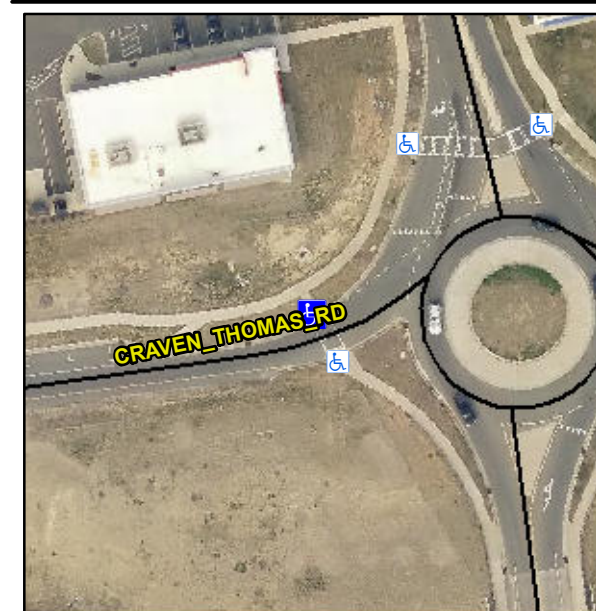
R304.2.2, R304.5.3

Compliance	Description	Data	Compliance	Description	Data
N/A	Ramp Length (in)	103.0	No	Ramp Slope (%)	10.9
Yes	Ramp Width (in)	48.0	No	Ramp XSlope (%)	2.3
N/A	Flare Type LT	N/A	N/A	Flare Type RT	N/A
N/A	Flare Slope LT (%)	N/A	N/A	Flare Slope RT (%)	N/A
N/A	Flare Traversable LT?	N/A	N/A	Flare Traversable RT?	N/A
N/A	Landing Length (in)	N/A	N/A	DWS Provided?	N/A
N/A	Landing Width (in)	N/A	N/A	DWS Contrast?	N/A
N/A	Landing Slope (%)	N/A	N/A	DWS Length (in)	N/A
N/A	Landing X Slope (%)	N/A	N/A	DWS Full Width?	N/A
N/A	Landing Curb? (Y/N)	N/A	N/A	DWS Offset (in)	N/A
N/A	Shared Landing?	N/A			
N/A	Gutter Ponding?	N/A	N/A	Gutter Slope (%)	N/A
N/A	Gutter Lip Ht (in)	N/A	N/A	Gutter X Slope (%)	N/A
N/A	Painted X Walk1?	Yes	N/A	Painted X Walk2?	N/A
	X Walk 1 Direction	To S		X Walk 2 Direction	N/A
N/A	X Walk 1 Width (in)	105.0	N/A	X Walk 2 Width (in)	N/A
	X Walk 1 Slope (%)	3.1		X Walk 2 Slope (%)	N/A
	X Walk 1 X Slope (%)	1.1		X Walk 2 X Slope (%)	N/A

N/A	Ramp inside XWalk1?	Yes	N/A	Ramp inside XWalk2?	N/A
	Road Slope (%)	N/A	N/A	Clear Space?	N/A
	Road X Slope (%)	N/A	N/A	Clear Space to XWalk (in)	N/A
N/A	Any Obstructions?	N/A	N/A	Storm Grate/Utility Hazard?	N/A
	Obstruction Type			Storm Grate/Utility Type	
		N/A			N/A
			Yes	Surface Condition? (G/P)	Good

Remove & Replace Entire Ramp.

Total Cost: \$ 1850.00
