Intersection ID: 10042371	Main Street: WYALONG_DR	Cross Street: N/A	Location:	SE
ADA ID: A3B963AF25E4	Ramp Type: BlendTrans1	Initial Pass/Fail: Fail	Overall Compliance: No	Severity Score: 1.25

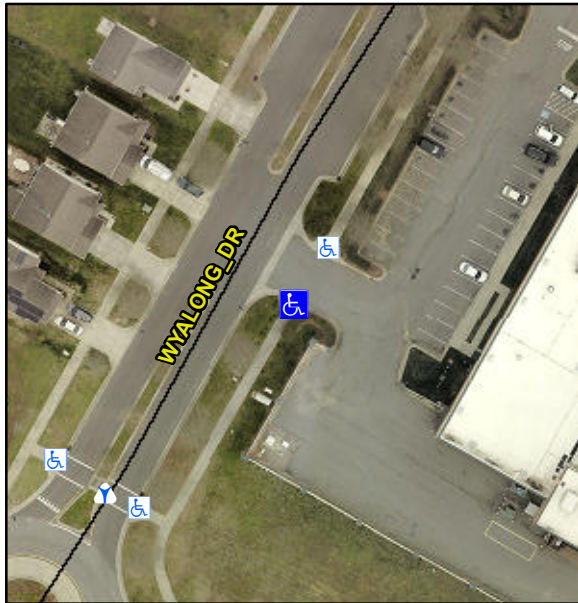
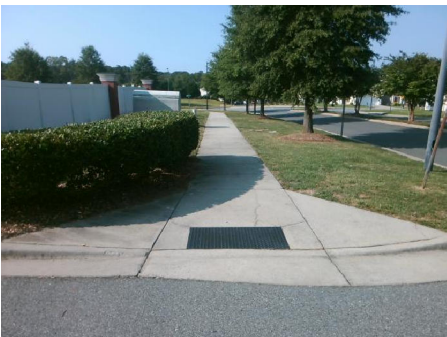
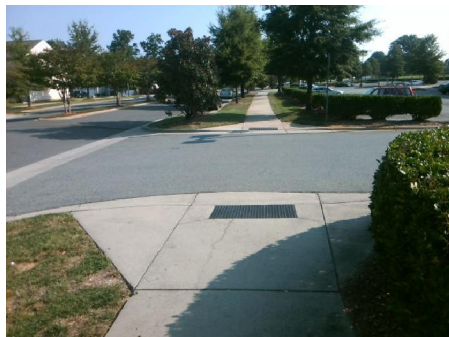
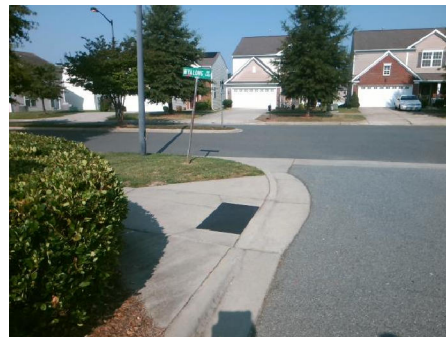
R304.5.3

Compliance	Description	Data	Compliance	Description	Data
N/A	Ramp Length (in)	96.0	Yes	BlendTrans Slope (%)	4.2
Yes	Ramp Width (in)	76.5	No	BlendTrans XSlope (%)	2.3
N/A	Flare Type LT	N/A	N/A	Flare Type RT	N/A
N/A	Flare Slope LT (%)	N/A	N/A	Flare Slope RT (%)	N/A
N/A	Flare Traversable LT?	N/A	N/A	Flare Traversable RT?	N/A
N/A	Landing Length (in)	N/A	N/A	DWS Provided?	N/A
N/A	Landing Width (in)	N/A	N/A	DWS Contrast?	N/A
N/A	Landing Slope (%)	N/A	N/A	DWS Length (in)	N/A
N/A	Landing X Slope (%)	N/A	N/A	DWS Full Width?	N/A
N/A	Landing Curb? (Y/N)	N/A	N/A	DWS Offset (in)	N/A
N/A	Shared Landing?	N/A			
N/A	Gutter Ponding?	N/A	N/A	Gutter Slope (%)	N/A
N/A	Gutter Lip Ht (in)	N/A	N/A	Gutter X Slope (%)	N/A
N/A	Painted X Walk1?	No	N/A	Painted X Walk2?	N/A
	X Walk 1 Direction	To NE		X Walk 2 Direction	N/A
	X Walk 1 Width (in)	N/A		X Walk 2 Width (in)	N/A
	X Walk 1 Slope (%)	0.8		X Walk 2 Slope (%)	N/A
	X Walk 1 X Slope (%)	0.2		X Walk 2 X Slope (%)	N/A

N/A	Ramp inside XWalk1?	N/A	N/A	Ramp inside XWalk2?	N/A
	Road Slope (%)	0.2		Clear Space?	N/A
	Road X Slope (%)	0.8	N/A	Clear Space to XWalk (in)	N/A
N/A	Any Obstructions?	N/A	N/A	Storm Grate/Utility Hazard?	N/A
	Obstruction Type			Storm Grate/Utility Type	
		N/A			N/A
			Yes	Surface Condition? (G/P)	Good
			N/A	Curb Slope (%)	1.4

Remove & Replace Curb Ramp With Two New Directional Ramps or Equivalent.

\$ 3200.00
