# Access Compliance Report

## Public Rights-of-Way

### (Curb Ramps)

| Intersection ID: 44929 | Main Street: TWIN_BROOK_DR | Cross Street: NATHAN_DR | Location: NE |

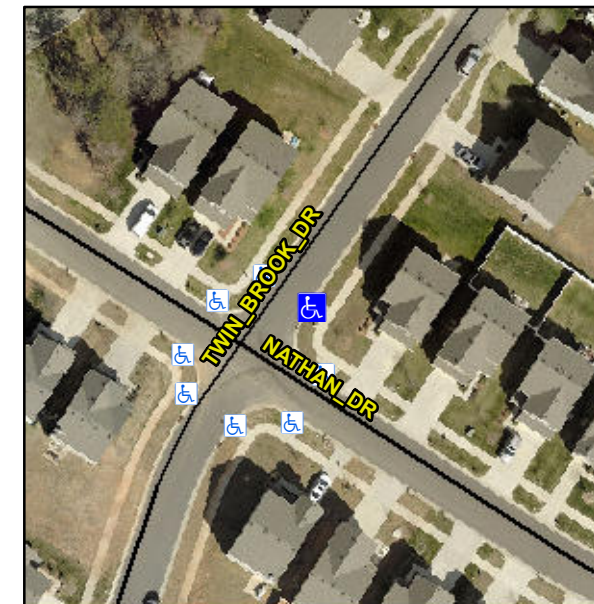
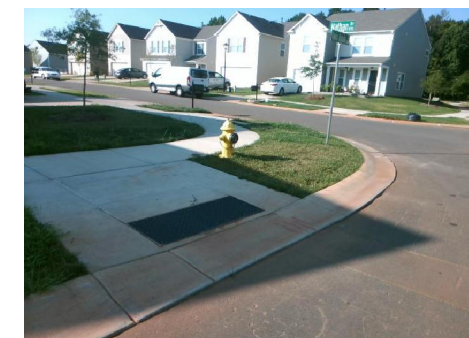
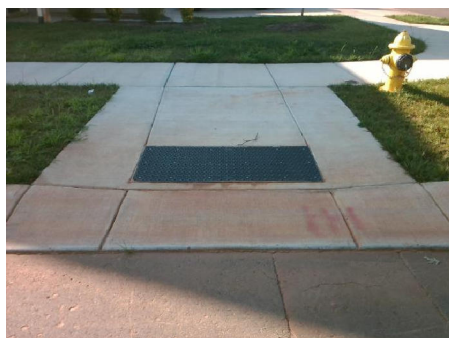
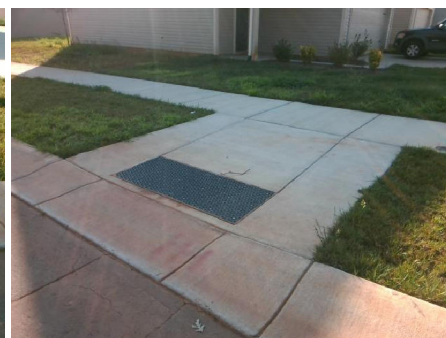
**Not Found, R304.2.2**

| Compliance | Description | Data | Compliance | Description | Data |
|---|---|---|---|---|---|
| N/A | Ramp Length (in) | 96.5 | No | Ramp Slope (%) | 10.0 |

**Remove & Replace Entire Ramp.**
