# Access Compliance Report

## Public Rights-of-Way

### (Curb Ramps)

Intersection ID: 25717	Main Street: WOODLEIGH_OAKS_DR	Cross Street: WOODMERE_CROSSING_LN	Location: W
ADA ID: A3C20978A19F	Ramp Type: Perp	Initial Pass/Fail: Fail	Overall Compliance: No
Severity Score: 10			
Codes/Mitigation Info/Possible Solution		Field Measurements/Component Compliance

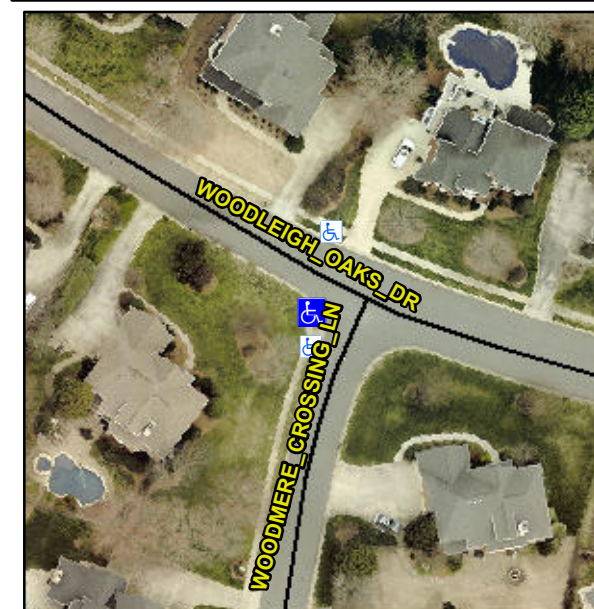
PROW/ADA:

**Not Found, R304.5.1, R304.5.3**

Compliance	Description	Data	Compliance	Description	Data
N/A	Ramp Length (in)	94.0	Yes	Ramp Slope (%)	5.5
No	Ramp Width (in)	40.0	No	Ramp XSlope (%)	3.8
N/A	Flare Type LT	N/A	N/A	Flare Type RT	N/A
N/A	Flare Slope LT (%)	N/A	N/A	Flare Slope RT (%)	N/A
N/A	Flare Traversable LT?	N/A	N/A	Flare Traversable RT?	N/A
N/A	Landing Length (in)	N/A	N/A	DWS Provided?	N/A
N/A	Landing Width (in)	N/A	N/A	DWS Contrast?	N/A
N/A	Landing Slope (%)	N/A	N/A	DWS Length (in)	N/A
N/A	Landing X Slope (%)	N/A	N/A	DWS Full Width?	N/A
N/A	Landing Curb? (Y/N)	N/A	N/A	DWS Offset (in)	N/A
N/A	Shared Landing?	N/A			
N/A	Gutter Ponding?	N/A	N/A	Gutter Slope (%)	N/A
N/A	Gutter Lip Ht (in)	N/A	N/A	Gutter X Slope (%)	N/A
N/A	Painted X Walk1?	No	N/A	Painted X Walk2?	N/A
	X Walk 1 Direction	To NE		X Walk 2 Direction	N/A
N/A	X Walk 1 Width (in)	N/A	N/A	X Walk 2 Width (in)	N/A
	X Walk 1 Slope (%)	4.4		X Walk 2 Slope (%)	N/A
	X Walk 1 X Slope (%)	1.9		X Walk 2 X Slope (%)	N/A

N/A	Ramp inside XWalk1?	N/A	N/A	Ramp inside XWalk2?	N/A
	Road Slope (%)	N/A	N/A	Clear Space?	N/A
	Road X Slope (%)	N/A	N/A	Clear Space to XWalk (in)	N/A
N/A	Any Obstructions?	N/A	N/A	Storm Grate/Utility Hazard?	N/A
	Obstruction Type			Storm Grate/Utility Type	
		N/A			N/A
			Yes	Surface Condition? (G/P)	Good

Possible Solutions:

**Remove & Replace Entire Ramp.**

Total Cost: \$ 1850.00
