Access Compliance Report

Public Rights-of-Way

(Curb Ramps)

Intersection ID: 27192	Main Street: MCKEE_RD	Cross Street: TILLEY_MORRIS_RD	Location: E
ADA ID: A3C405BFA74A	Ramp Type: Directional1	Initial Pass/Fail: Pass	Overall Compliance: No
			Severity Score: 7.75
Codes/Mitigation Info/Possible Solution		Field Measurements/Component Compliance

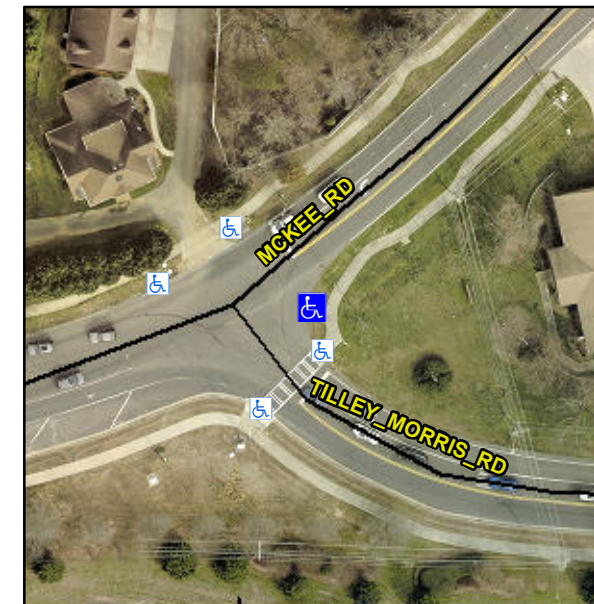
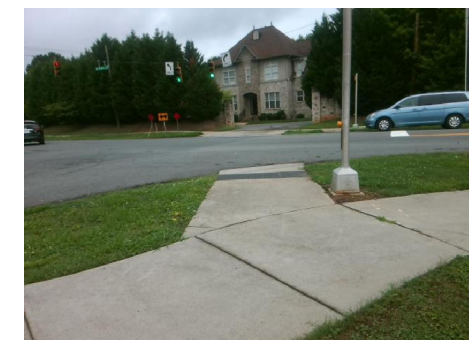
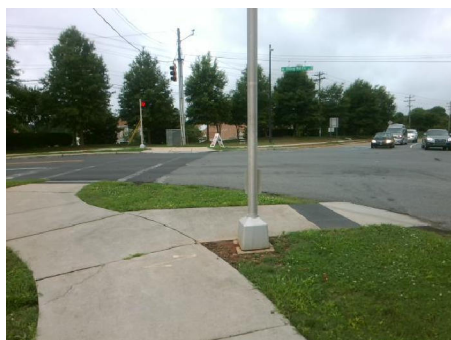
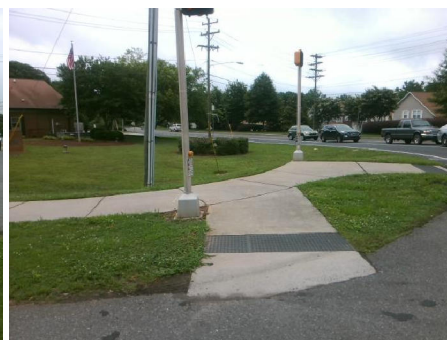
NO CURB

R304.5.3, R305.2, R302.7.2

Compliance	Description	Data	Compliance	Description	Data
N/A	Ramp Length (in)	93.0	Yes	Grade Break?	Yes
Yes	Ramp Width (in)	72.0	Yes	Grade Break Slope (%)	1.1
Yes	Ramp Slope (%)	1.1	Yes	Grade Break XSlope (%)	0.5
No	Ramp XSlope (%)	2.5			
N/A	Flare Type LT	N/A	N/A	Flare Type RT	N/A
N/A	Flare Slope LT (%)	N/A	N/A	Flare Slope RT (%)	N/A
N/A	Flare Traversable LT?	N/A	N/A	Flare Traversable RT?	N/A
Yes	Landing Length (in)	48.0	Yes	DWS Provided?	Yes
Yes	Landing Width (in)	72.0	Yes	DWS Contrast?	Yes
Yes	Landing Slope (%)	0.0	Yes	DWS Length (in)	24.0
No	Landing X Slope (%)	4.6	Yes	DWS Full Width?	Yes
N/A	Landing Curb? (Y/N)	No	Yes	DWS Offset LT (in)	34.0
N/A	Shared Landing?	No	No	DWS Offset RT (in)	5.0
Yes	Gutter Ponding?	No	Yes	Gutter Slope (%)	0.3
No	Gutter Lip Ht (in)	0.5	Yes	Gutter X Slope (%)	0.2
N/A	Painted X Walk1?	No		Road Slope (%)	1.7
	X Walk 1 Direction	To NW		Road X Slope (%)	1.1
	X Walk 1 Width (in)	N/A		Clear Space?	Yes

X Walk 1 Slope (%)	1.7	N/A	Clear Space to XWalk (in)	N/A
	X Walk 1 X Slope (%)	1.1	Yes	Storm Grate/Utility Hazard?	No
N/A	Ramp inside XWalk1?	N/A		Storm Grate/Utility Type	
Yes	Any Obstructions?	No			N/A
	Obstruction Type		Yes	Surface Condition? (G/P)	Good
			N/A	Curb Slope (%)	N/A

**Remove & Replace Entire Ramp.
Grind Gutter Lip.**
