Access Compliance Report

Public Rights-of-Way

(Curb Ramps)

Intersection ID: 44310	Main Street: LINDA_VISTA_LN	Cross Street: KIEV_DR	Location: NE
ADA ID: A3C8FDCA0F07	Ramp Type: Perp	Initial Pass/Fail: Fail	Overall Compliance: No
Severity Score: 22.5			
Codes/Mitigation Info/Possible Solution		Field Measurements/Component Compliance

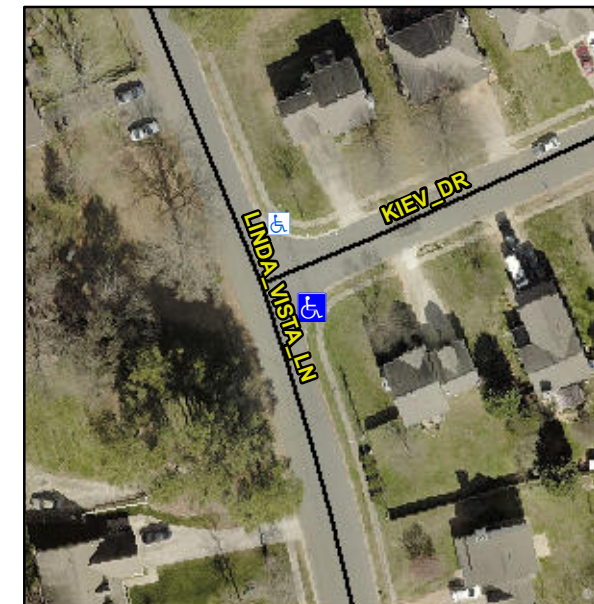
Not Found, R304.5.1, R304.2.2, R304.5.3

Compliance	Description	Data	Compliance	Description	Data
N/A	Ramp Length (in)	48.0	No	Ramp Slope (%)	9.2
No	Ramp Width (in)	41.5	No	Ramp XSlope (%)	2.9
N/A	Flare Type LT	N/A	N/A	Flare Type RT	N/A
N/A	Flare Slope LT (%)	N/A	N/A	Flare Slope RT (%)	N/A
N/A	Flare Traversable LT?	N/A	N/A	Flare Traversable RT?	N/A
N/A	Landing Length (in)	N/A	N/A	DWS Provided?	N/A
N/A	Landing Width (in)	N/A	N/A	DWS Contrast?	N/A
N/A	Landing Slope (%)	N/A	N/A	DWS Length (in)	N/A
N/A	Landing X Slope (%)	N/A	N/A	DWS Full Width?	N/A
N/A	Landing Curb? (Y/N)	N/A	N/A	DWS Offset (in)	N/A
N/A	Shared Landing?	N/A			
N/A	Gutter Ponding?	N/A	N/A	Gutter Slope (%)	N/A
N/A	Gutter Lip Ht (in)	N/A	N/A	Gutter X Slope (%)	N/A
N/A	Painted X Walk1?	No	N/A	Painted X Walk2?	N/A
	X Walk 1 Direction	To N		X Walk 2 Direction	N/A
N/A	X Walk 1 Width (in)	N/A	N/A	X Walk 2 Width (in)	N/A
	X Walk 1 Slope (%)	0.8		X Walk 2 Slope (%)	N/A
	X Walk 1 X Slope (%)	1.9		X Walk 2 X Slope (%)	N/A

N/A	Ramp inside XWalk1?	N/A	N/A	Ramp inside XWalk2?	N/A
	Road Slope (%)	N/A	N/A	Clear Space?	N/A
	Road X Slope (%)	N/A	N/A	Clear Space to XWalk (in)	N/A
N/A	Any Obstructions?	N/A	N/A	Storm Grate/Utility Hazard?	N/A
	Obstruction Type			Storm Grate/Utility Type	
		N/A			N/A
			Yes	Surface Condition? (G/P)	Good

Remove & Replace Entire Ramp.

Total Cost: \$ 1850.00
