Access Compliance Report

Public Rights-of-Way (Curb Ramps)

Intersection ID: 16365	Main Street: QUEENS_RD	Cross Street: SHERWOOD_AV	Location: NW
ADA ID: A3D3538FE37B	Ramp Type: Directional1	Initial Pass/Fail: Fail	Overall Compliance: No
			Severity Score: 21.25

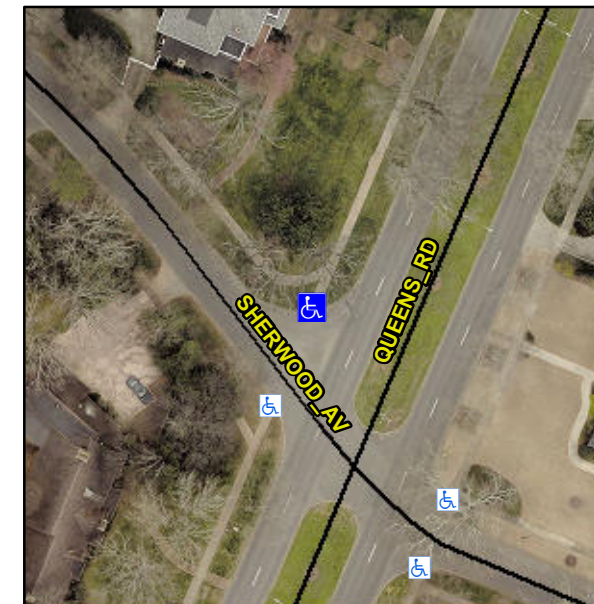
R304.5.1, R304.5.3

Compliance	Description	Data	Compliance	Description	Data
N/A	Ramp Length (in)	71.0	N/A	Grade Break?	N/A
No	Ramp Width (in)	44.0	N/A	Grade Break Slope (%)	0.0
Yes	Ramp Slope (%)	5.3	N/A	Grade Break XSlope (%)	0.0
No	Ramp XSlope (%)	5.5			
N/A	Flare Type LT	N/A	N/A	Flare Type RT	N/A
N/A	Flare Slope LT (%)	N/A	N/A	Flare Slope RT (%)	0.0
N/A	Flare Traversable LT?	N/A	N/A	Flare Traversable RT?	N/A
N/A	Landing Length (in)	0.0	N/A	DWS Provided?	N/A
N/A	Landing Width (in)	0.0	N/A	DWS Contrast?	N/A
N/A	Landing Slope (%)	0.0	N/A	DWS Length (in)	N/A
N/A	Landing X Slope (%)	0.0	N/A	DWS Full Width?	N/A
N/A	Landing Curb? (Y/N)	N/A	N/A	DWS Offset LT (in)	N/A
N/A	Shared Landing?	N/A	N/A	DWS Offset RT (in)	N/A
N/A	Gutter Ponding?	0.0	N/A	Gutter Slope (%)	N/A
N/A	Gutter Lip Ht (in)	0.0	N/A	Gutter X Slope (%)	N/A
N/A	Painted X Walk1?	No		Road Slope (%)	1.3
	X Walk 1 Direction	To S		Road X Slope (%)	1.2
	X Walk 1 Width (in)	N/A		Clear Space?	N/A

X Walk 1 Slope (%)	1.3	N/A	Clear Space to XWalk (in)	N/A
	X Walk 1 X Slope (%)	1.2	N/A	Storm Grate/Utility Hazard?	N/A
N/A	Ramp inside XWalk1?	N/A		Storm Grate/Utility Type	
N/A	Any Obstructions?	N/A			N/A
	Obstruction Type		Yes	Surface Condition? (G/P)	Good
			N/A	Curb Slope (%)	10.4

Remove & Replace Entire Ramp.
