# Access Compliance Report

## Public Rights-of-Way

### (Curb Ramps)

Intersection ID: 13818	Main Street: CENTRAL_AV	Cross Street: SHERIDAN_DR	Location: SE
ADA ID: A3E3BA461157	Ramp Type: Perp	Initial Pass/Fail: Fail	Overall Compliance: No
Codes/Mitigation Info/Possible Solution			Severity Score: 30
			Field Measurements/Component Compliance

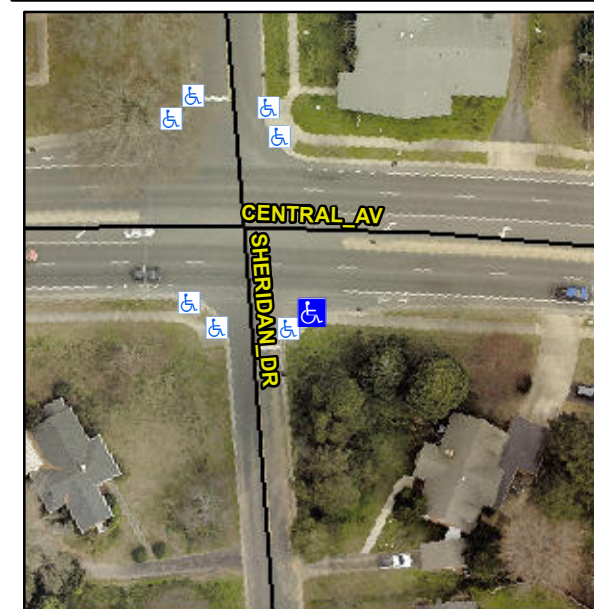
**Not Found, R304.5.1, R304.5.3**

Compliance	Description	Data	Compliance	Description	Data
N/A	Ramp Length (in)	72.0	Yes	Ramp Slope (%)	7.1
No	Ramp Width (in)	33.5	No	Ramp XSlope (%)	5.1
N/A	Flare Type LT	N/A	N/A	Flare Type RT	N/A
N/A	Flare Slope LT (%)	N/A	N/A	Flare Slope RT (%)	N/A
N/A	Flare Traversable LT?	N/A	N/A	Flare Traversable RT?	N/A
N/A	Landing Length (in)	N/A	N/A	DWS Provided?	N/A
N/A	Landing Width (in)	N/A	N/A	DWS Contrast?	N/A
N/A	Landing Slope (%)	N/A	N/A	DWS Length (in)	N/A
N/A	Landing X Slope (%)	N/A	N/A	DWS Full Width?	N/A
N/A	Landing Curb? (Y/N)	N/A	N/A	DWS Offset (in)	N/A
N/A	Shared Landing?	N/A			
N/A	Gutter Ponding?	N/A	N/A	Gutter Slope (%)	N/A
N/A	Gutter Lip Ht (in)	N/A	N/A	Gutter X Slope (%)	N/A
N/A	Painted X Walk1?	No	N/A	Painted X Walk2?	N/A
	X Walk 1 Direction	To N		X Walk 2 Direction	N/A
N/A	X Walk 1 Width (in)	N/A	N/A	X Walk 2 Width (in)	N/A
	X Walk 1 Slope (%)	5.3		X Walk 2 Slope (%)	N/A
	X Walk 1 X Slope (%)	1.0		X Walk 2 X Slope (%)	N/A

N/A	Ramp inside XWalk1?	N/A	N/A	Ramp inside XWalk2?	N/A
	Road Slope (%)	N/A	N/A	Clear Space?	N/A
	Road X Slope (%)	N/A	N/A	Clear Space to XWalk (in)	N/A
N/A	Any Obstructions?	N/A	N/A	Storm Grate/Utility Hazard?	N/A
	Obstruction Type			Storm Grate/Utility Type	
		N/A			N/A
			Yes	Surface Condition? (G/P)	Good

Possible Solutions:

**Remove & Replace Entire Ramp.**
