# Access Compliance Report

## Public Rights-of-Way

### (Curb Ramps)

Intersection ID: 24503	Main Street: BRUFF_CT	Cross Street: SAINTFIELD_PL	Location: SE
ADA ID: A3E875B1C708	Ramp Type: Perp	Initial Pass/Fail: Fail	Overall Compliance: No
Codes/Mitigation Info/Possible Solution		Field Measurements/Component Compliance

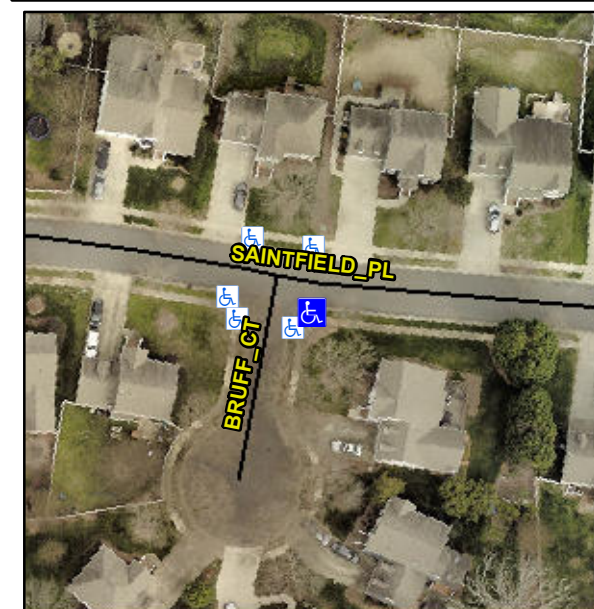
**Not Found, R304.5.1, R304.2.2**

Compliance	Description	Data	Compliance	Description	Data
N/A	Ramp Length (in)	48.0	No	Ramp Slope (%)	9.2
No	Ramp Width (in)	43.0	Yes	Ramp XSlope (%)	0.4
N/A	Flare Type LT	N/A	N/A	Flare Type RT	N/A
N/A	Flare Slope LT (%)	N/A	N/A	Flare Slope RT (%)	N/A
N/A	Flare Traversable LT?	N/A	N/A	Flare Traversable RT?	N/A
N/A	Landing Length (in)	N/A	N/A	DWS Provided?	N/A
N/A	Landing Width (in)	N/A	N/A	DWS Contrast?	N/A
N/A	Landing Slope (%)	N/A	N/A	DWS Length (in)	N/A
N/A	Landing X Slope (%)	N/A	N/A	DWS Full Width?	N/A
N/A	Landing Curb? (Y/N)	N/A	N/A	DWS Offset (in)	N/A
N/A	Shared Landing?	N/A			
N/A	Gutter Ponding?	N/A	N/A	Gutter Slope (%)	N/A
N/A	Gutter Lip Ht (in)	N/A	N/A	Gutter X Slope (%)	N/A
N/A	Painted X Walk1?	No	N/A	Painted X Walk2?	N/A
	X Walk 1 Direction	To N		X Walk 2 Direction	N/A
N/A	X Walk 1 Width (in)	N/A	N/A	X Walk 2 Width (in)	N/A
	X Walk 1 Slope (%)	0.2		X Walk 2 Slope (%)	N/A
	X Walk 1 X Slope (%)	0.3		X Walk 2 X Slope (%)	N/A

**Remove & Replace Entire Ramp.**

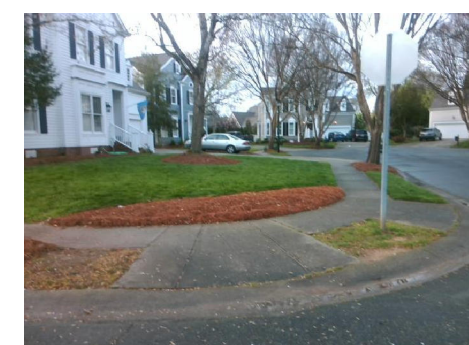
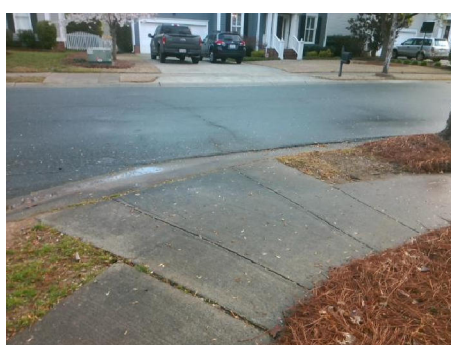
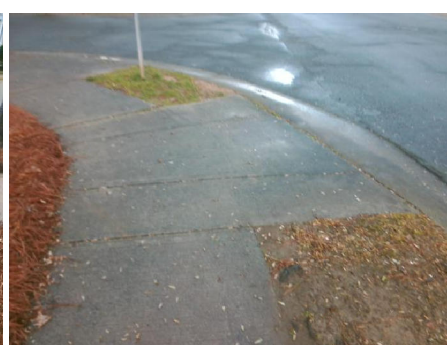
N/A	Ramp inside XWalk1?	N/A	N/A	Ramp inside XWalk2?	N/A
	Road Slope (%)	N/A	N/A	Clear Space?	N/A
	Road X Slope (%)	N/A	N/A	Clear Space to XWalk (in)	N/A
N/A	Any Obstructions?	N/A	N/A	Storm Grate/Utility Hazard?	N/A
	Obstruction Type			Storm Grate/Utility Type	
		N/A			N/A
			Yes	Surface Condition? (G/P)	Good
