# Access Compliance Report

## Public Rights-of-Way

| Intersection ID: 3350 | Main Street: FALLS_RIDGE_LN | Cross Street: CANIPE_DR | Location: | S |
| ADA ID: A3E9246E23EF | Ramp Type: Perp | Initial Pass/Fail: Fail | Overall Compliance: No | Severity Score: 8.75 |

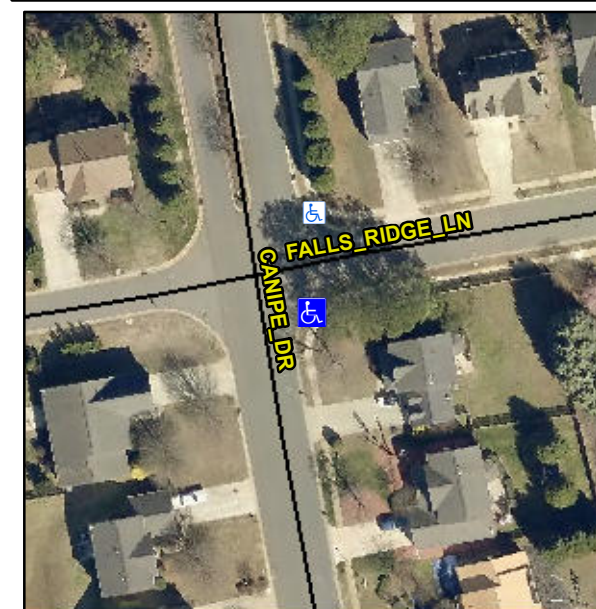
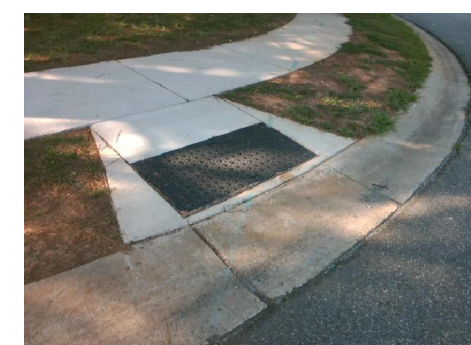
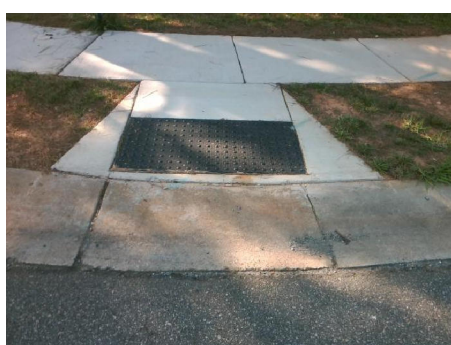
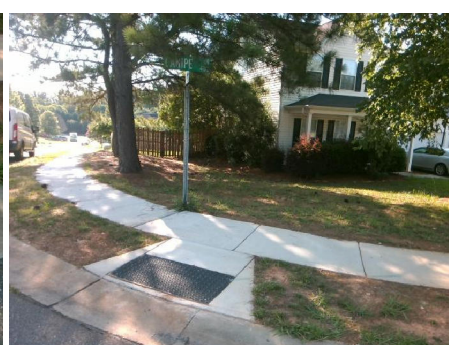
**Not Found, R304.5.1**

| Compliance | Description | Data | Compliance | Description | Data |
|---|---|---|---|---|---|
| No | Ramp Width (in) | 47.0 | Yes | Ramp XSlope (%) | 1.5 |

**Remove & Replace Entire Ramp.**

Total Cost: \$ 1850.00
