Access Compliance Report

Public Rights-of-Way

(Curb Ramps)

Intersection ID: 13345	Main Street: COMMONWEALTH_AV	Cross Street: THOMAS_AV	Location: NE
ADA ID: A3FB17DA881C	Ramp Type: Perp	Initial Pass/Fail: Fail	Overall Compliance: No
		Severity Score: 8.75

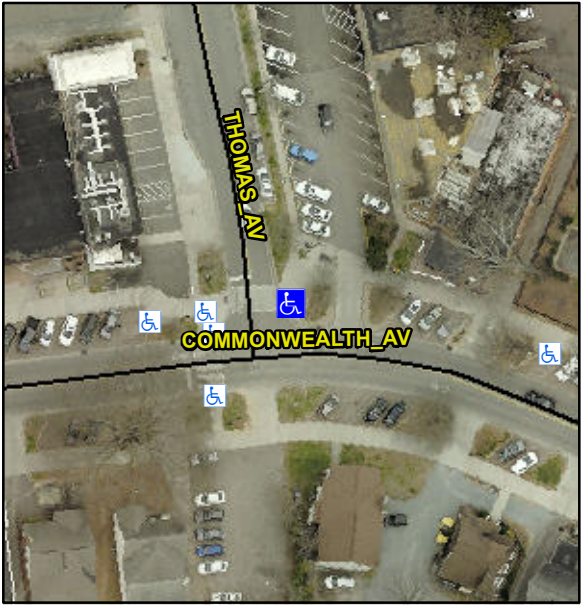
Possible Solutions:		Compliance	Description	Data
	Remove & Replace Entire Ramp.		Yes	Ramp Slope (%)	7.6
			No	Ramp Width (in)	1.2
			N/A	Flare Type LT	N/A
			N/A	Flare Slope LT (%)	N/A
			N/A	Flare Traversable LT?	N/A
			N/A	Landing Length (in)	N/A
			N/A	Landing Width (in)	N/A
			N/A	Landing Slope (%)	N/A
			N/A	Landing X Slope (%)	N/A
<p>Surveyor Notes:</p> <p>N/A</p> <p>PROW/ADA:</p> <p>Not Found, R304.5.1</p>			N/A	Flare Type RT	N/A
			N/A	Flare Slope RT (%)	N/A
			N/A	Flare Traversable RT?	N/A
			N/A	DWS Provided?	N/A
			N/A	DWS Contrast?	N/A
			N/A	DWS Length (in)	N/A
			N/A	DWS Full Width?	N/A
			N/A	DWS Offset (in)	N/A
			N/A	Shared Landing?	N/A
			N/A	Gutter Ponding?	N/A
			N/A	Gutter Lip Ht (in)	N/A
			N/A	Painted X Walk1?	N/A
			Yes	Painted X Walk2?	N/A
			To W	X Walk 2 Direction	N/A
			N/A	X Walk 2 Width (in)	N/A

1.8	X Walk 2 Slope (%)	N/A
			1.3	X Walk 2 X Slope (%)	N/A
			N/A	Ramp inside XWalk2?	N/A
			N/A	Clear Space?	N/A
			N/A	Clear Space to XWalk (in)	N/A
			N/A	Any Obstructions?	N/A
			N/A	Obstruction Type	N/A
			N/A	Storm Grate/Utility Hazard?	N/A
			N/A	Storm Grate/Utility Type	N/A
			N/A	Surface Condition? (G/P)	Good
Total Cost:		\$ 1850.00
