Access Compliance Report

Public Rights-of-Way

(Curb Ramps)

Intersection ID: 31687	Main Street: GALLISON_AV	Cross Street: VALENDRA_DR	Location: NW
ADA ID: A40DBB14180D	Ramp Type: PerpDiag	Initial Pass/Fail: Fail	Overall Compliance: No
		Severity Score: 25

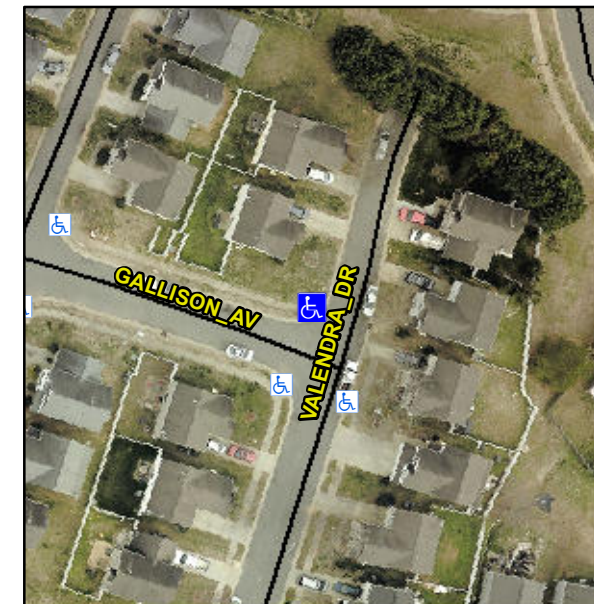
Compliance	Description	Data	Compliance	Description	Data
N/A	Ramp Length (in)	47.5	Yes	Ramp Slope (%)	5.4
Yes	Ramp Width (in)	56.0	No	Ramp XSlope (%)	8.6
N/A	Flare Type LT	N/A	N/A	Flare Type RT	N/A
N/A	Flare Slope LT (%)	N/A	N/A	Flare Slope RT (%)	N/A
N/A	Flare Traversable LT?	N/A	N/A	Flare Traversable RT?	N/A
N/A	Landing Length (in)	N/A	N/A	DWS Provided?	N/A
N/A	Landing Width (in)	N/A	N/A	DWS Contrast?	N/A
N/A	Landing Slope (%)	N/A	N/A	DWS Length (in)	N/A
N/A	Landing X Slope (%)	N/A	N/A	DWS Full Width?	N/A
N/A	Landing Curb? (Y/N)	N/A	N/A	DWS Offset (in)	N/A
N/A	Shared Landing?	N/A			
N/A	Gutter Ponding?	N/A	N/A	Gutter Slope (%)	N/A
N/A	Gutter Lip Ht (in)	N/A	N/A	Gutter X Slope (%)	N/A
N/A	Painted X Walk1?	No	N/A	Painted X Walk2?	No
	X Walk 1 Direction	To SW		X Walk 2 Direction	To SE
N/A	X Walk 1 Width (in)	N/A	N/A	X Walk 2 Width (in)	N/A
	X Walk 1 Slope (%)	2.4		X Walk 2 Slope (%)	1.0
	X Walk 1 X Slope (%)	1.3		X Walk 2 X Slope (%)	2.4

N/A	Ramp inside XWalk1?	N/A	N/A	Ramp inside XWalk2?	N/A
	Road Slope (%)	3.0	N/A	Clear Space?	N/A
	Road X Slope (%)	3.6	N/A	Clear Space to XWalk (in)	N/A
N/A	Any Obstructions?	N/A	N/A	Storm Grate/Utility Hazard?	N/A
	Obstruction Type			Storm Grate/Utility Type	
		N/A			N/A
			Yes	Surface Condition? (G/P)	Good

Remove & Replace Curb Ramp With Two New Directional Ramps or Equivalent.

R304.5.3

Total Cost: \$ 3200.00
