Access Compliance Report Public Rights-of-Way (Curb Ramps)

Intersection ID: 28936 Main Street: CHRISTENBURY RD Cross Street: BRANDIE_GLEN_RD Location: NW ADA ID: A413C671E150 Ramp Type: Perp Initial Pass/Fail: Fail **Overall Compliance: No Severity Score:** 17.5

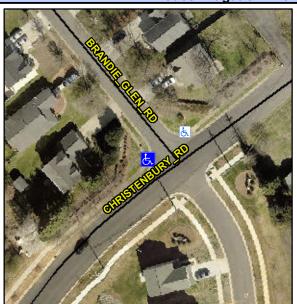
N/A Ramp Length (in) 92.5 Yes Ramp Slope (%) 7 No Ramp Width (in) 35.5 Yes Ramp XSlope (%) 0 N/A Flare Type LT N/A N/A Flare Type RT N	7.8 0.6 1/A 1/A 1/A 1/A
No Ramp Width (in) 35.5 Yes Ramp XSlope (%) N/A Flare Type LT N/A N/A Flare Type RT N	0.6 I/A I/A I/A I/A I/A
N/A Flare Type LT N/A N/A Flare Type RT N	1/A 1/A 1/A 1/A 1/A
	1/A 1/A 1/A 1/A
N/A Flare Slope LT (%) N/A N/A Flare Slope RT (%) N	1/A 1/A 1/A 1/A
	1/A 1/A 1/A
N/A Flare Traversable LT? N/A N/A Flare Traversable RT? N	I/A I/A
N/A Landing Length (in) N/A N/A DWS Provided?	I/A
N/A Landing Width (in) N/A N/A DWS Contrast? N	
N/A Landing Slope (%) N/A N/A DWS Length (in) N	
N/A Landing X Slope (%) N/A N/A DWS Full Width? N	I/A
N/A Landing Curb? (Y/N) N/A N/A DWS Offset (in) N	I/A
N/A Shared Landing? N/A	
N/A Gutter Ponding? N/A N/A Gutter Slope (%)	I/A
N/A Gutter Lip Ht (in) N/A N/A Gutter X Slope (%)	I/A
N/A Painted X Walk1? No N/A Painted X Walk2? N	I/A

X Walk 1 Direction To NE X Walk 2 Direction N	I/A
N/A X Walk 1 Width (in) N/A N/A X Walk 2 Width (in) N	I/A
X Walk 1 Slope (%) 0.1 X Walk 2 Slope (%) N	I/A
X Walk 1 X Slope (%) 2.8 X Walk 2 X Slope (%) N	I/A
N/A Ramp inside XWalk1? N/A N/A Ramp inside XWalk2? N	I/A
Road Slope (%) N/A N/A Clear Space? N	I/A
Road X Slope (%) N/A Clear Space to XWalk (in) N	I/A
N/A Any Obstructions? N/A N/A Storm Grate/Utility Hazard? N	I/A
Obstruction Type Storm Grate/Utility Type	
N/A N	I/A
Yes Surface Condition? (G/P) God	od

BRANDIE GLEN RD Street 1 Name Stop Condition-Street 2 StopSign Street 2 Name N/A Stop Condition-Street 1 N/A Possible Solutions: Remove & Replace Entire Ramp. Surveyor Notes: N/A PROW/ADA: Not Found, R304.5.1
