# Access Compliance Report

## Public Rights-of-Way

### (Curb Ramps)

Intersection ID: 10032173	Main Street: MORRIS_FIELD_DR	Cross Street: N/A	Location: SE
ADA ID: A41AB422A767	Ramp Type: Perp	Initial Pass/Fail: Fail	Overall Compliance: No
		Severity Score: 8.75

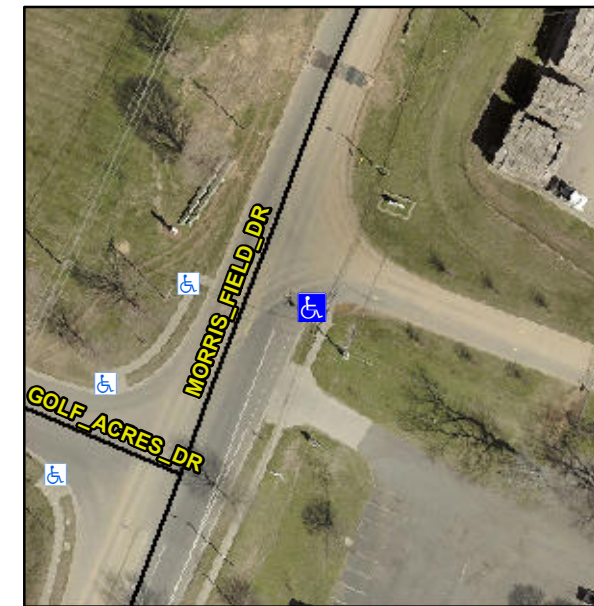
**Not Found, R304.5.1**

Compliance	Description	Data	Compliance	Description	Data
N/A	Ramp Length (in)	77.0	Yes	Ramp Slope (%)	5.3
No	Ramp Width (in)	47.0	Yes	Ramp XSlope (%)	1.4
N/A	Flare Type LT	N/A	N/A	Flare Type RT	N/A
N/A	Flare Slope LT (%)	N/A	N/A	Flare Slope RT (%)	N/A
N/A	Flare Traversable LT?	N/A	N/A	Flare Traversable RT?	N/A
N/A	Landing Length (in)	N/A	N/A	DWS Provided?	N/A
N/A	Landing Width (in)	N/A	N/A	DWS Contrast?	N/A
N/A	Landing Slope (%)	N/A	N/A	DWS Length (in)	N/A
N/A	Landing X Slope (%)	N/A	N/A	DWS Full Width?	N/A
N/A	Landing Curb? (Y/N)	N/A	N/A	DWS Offset (in)	N/A
N/A	Shared Landing?	N/A			
N/A	Gutter Ponding?	N/A	N/A	Gutter Slope (%)	N/A
N/A	Gutter Lip Ht (in)	N/A	N/A	Gutter X Slope (%)	N/A
N/A	Painted X Walk1?	No	N/A	Painted X Walk2?	N/A
	X Walk 1 Direction	To NW		X Walk 2 Direction	N/A
N/A	X Walk 1 Width (in)	N/A	N/A	X Walk 2 Width (in)	N/A
	X Walk 1 Slope (%)	2.5		X Walk 2 Slope (%)	N/A
	X Walk 1 X Slope (%)	2.8		X Walk 2 X Slope (%)	N/A

N/A	Ramp inside XWalk1?	N/A	N/A	Ramp inside XWalk2?	N/A
	Road Slope (%)	N/A	N/A	Clear Space?	N/A
	Road X Slope (%)	N/A	N/A	Clear Space to XWalk (in)	N/A
N/A	Any Obstructions?	N/A	N/A	Storm Grate/Utility Hazard?	N/A
	Obstruction Type			Storm Grate/Utility Type	
		N/A			N/A
			Yes	Surface Condition? (G/P)	Good

**Remove & Replace Entire Ramp.**
