Access Compliance Report

Public Rights-of-Way

(Curb Ramps)

Intersection ID: 45682	Main Street: SOUTHPARK_LN	Cross Street: PARK_SOUTH_DR	Location: NE
ADA ID: A42302119AB9	Ramp Type: ParaDiag	Initial Pass/Fail: Fail	Overall Compliance: No
Codes/Mitigation Info/Possible Solution		Field Measurements/Component Compliance	
Severity Score: 13.75

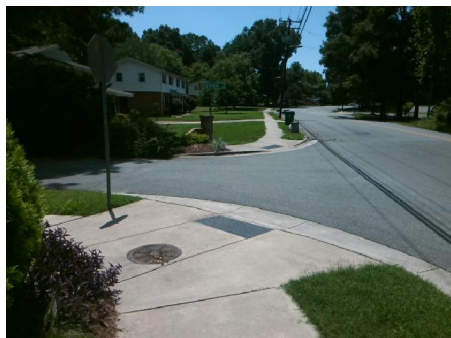
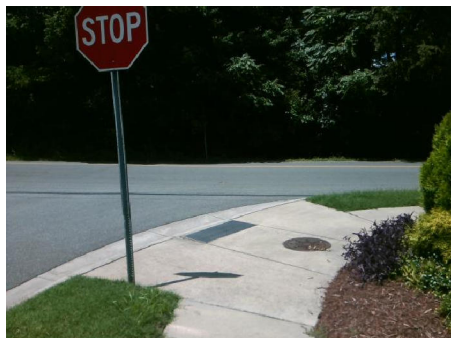
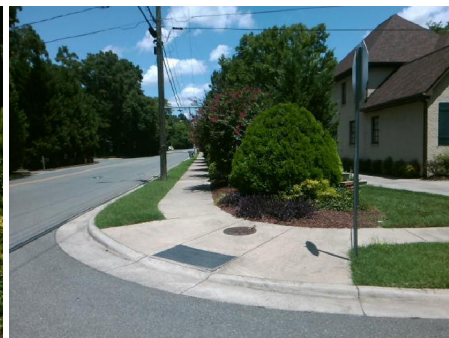
RT RP < 5%

R304.3.2, R304.5.3

Compliance	Description	Data	Compliance	Description	Data
N/A	Ramp Length LT (in)	29.0	N/A	Ramp Length RT (in)	40.0
Yes	Ramp Width LT (in)	60.0	Yes	Ramp Width RT (in)	52.0
No	Ramp Slope LT (%)	8.8	Yes	Ramp Slope RT (%)	1.4
Yes	Ramp XSlope LT (%)	0.6	No	Ramp XSlope RT (%)	2.4
N/A	Landing Length (in)	N/A	N/A	DWS Provided?	N/A
N/A	Landing Width (in)	N/A	N/A	DWS Contrast?	N/A
N/A	Landing Slope (%)	N/A	N/A	DWS Length (in)	N/A
N/A	Landing X Slope (%)	N/A	N/A	DWS Full Width?	N/A
N/A	Landing Curb? (Y/N)	N/A	N/A	DWS Offset (in)	N/A
N/A	Shared Landing?	N/A			
N/A	Gutter Ponding?	N/A	N/A	Gutter Slope (%)	N/A
N/A	Gutter Lip Ht (in)	N/A	N/A	Gutter X Slope (%)	N/A
N/A	Painted X Walk1?	No	N/A	Painted X Walk2?	No
	X Walk 1 Direction	To W		X Walk 2 Direction	To SW
N/A	X Walk 1 Width (in)	N/A	N/A	X Walk 2 Width (in)	N/A
	X Walk 1 Slope (%)	3.7		X Walk 2 Slope (%)	2.9
	X Walk 1 X Slope (%)	0.1		X Walk 2 X Slope (%)	2.9
N/A	Ramp inside XWalk1?	N/A	N/A	Ramp inside XWalk2?	N/A

Road Slope (%)	1.3	N/A	Clear Space?	N/A
	Road X Slope (%)	3.2	N/A	Clear Space to XWalk (in)	N/A
N/A	Any Obstructions?	N/A	N/A	Storm Grate/Utility Hazard?	N/A
	Obstruction Type			Storm Grate/Utility Type	
		N/A			N/A
			Yes	Surface Condition? (G/P)	Good
			N/A	Curb Slope (%)	18.1

Possible Solutions:

Remove & Replace Curb Ramp With Two New Directional Ramps or Equivalent.
