# Access Compliance Report

## Public Rights-of-Way

### (Curb Ramps)

| Intersection ID: 20185 | Main Street: FAIRVIEW_RD | Cross Street: PIEDMONT_ROW_DR | Location: NW |

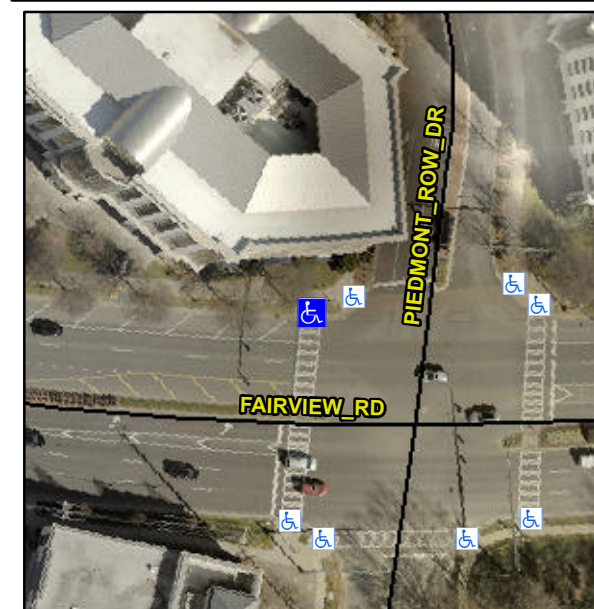
| ADA ID: A42548A9936C | Ramp Type: Perp | Initial Pass/Fail: Fail | Overall Compliance: No |
| Severity Score: 13.75 | | | |

| Compliance | Description | Data | Compliance | Description | Data |
|---|---|---|---|---|---|
| N/A | Ramp Length (in) | 95.0 | No | Ramp Slope (%) | 11.7 |
| Yes | Ramp Width (in) | 48.0 | No | Ramp XSlope (%) | 3.0 |

**Remove & Replace Entire Ramp.**

**R304.2.2, R304.5.3**

Total Cost: \$ 1850.00
