Access Compliance Report

Public Rights-of-Way

(Curb Ramps)

Intersection ID: 20840	Main Street: SARDIS_LN	Cross Street: SARDIS_RD	Location:	E
ADA ID: A42731C260B2	Ramp Type: Perp	Initial Pass/Fail: Fail	Overall Compliance: No	Severity Score: 22.5

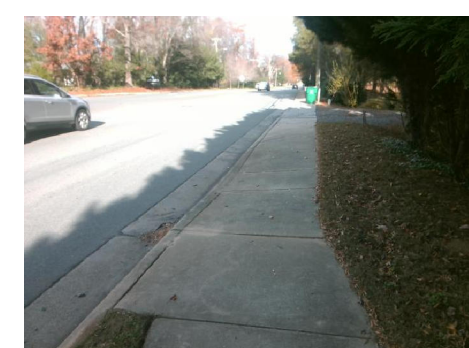
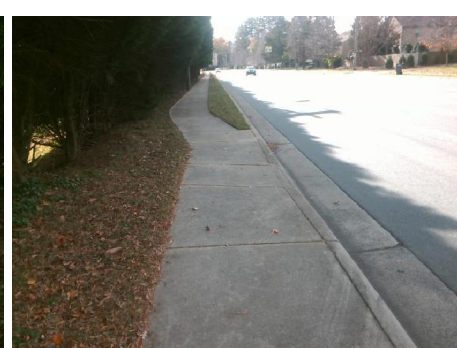
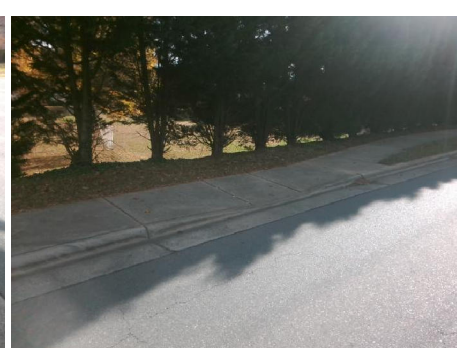
Possible Solutions:		Compliance	Description	Data	Compliance	Description	Data
	Remove & Replace Entire Ramp.		N/A	Ramp Length (in)	60.0	No	Ramp Slope (%)	9.4
			No	Ramp Width (in)	45.5	No	Ramp XSlope (%)	2.4
			N/A	Flare Type LT	N/A	N/A	Flare Type RT	N/A
			N/A	Flare Slope LT (%)	N/A	N/A	Flare Slope RT (%)	N/A
			N/A	Flare Traversable LT?	N/A	N/A	Flare Traversable RT?	N/A
			N/A	Landing Length (in)	N/A	N/A	DWS Provided?	N/A
			N/A	Landing Width (in)	N/A	N/A	DWS Contrast?	N/A
			N/A	Landing Slope (%)	N/A	N/A	DWS Length (in)	N/A
			N/A	Landing X Slope (%)	N/A	N/A	DWS Full Width?	N/A
Surveyor Notes:			N/A	Landing Curb? (Y/N)	N/A	N/A	DWS Offset (in)	N/A
N/A			N/A	Shared Landing?	N/A			
PROW/ADA:			N/A	Gutter Ponding?	N/A	N/A	Gutter Slope (%)	N/A
Not Found, R304.5.1, R304.2.2, R304.5.3			N/A	Gutter Lip Ht (in)	N/A	N/A	Gutter X Slope (%)	N/A
