# Access Compliance Report

## Public Rights-of-Way

### (Curb Ramps)

Intersection ID: 18216	Main Street: FOREST_DR	Cross Street: S_WENDOVER_RD	Location: E
ADA ID: A43C596767A2	Ramp Type: PerpDiag	Initial Pass/Fail: Fail	Overall Compliance: No
			Severity Score: 13.75

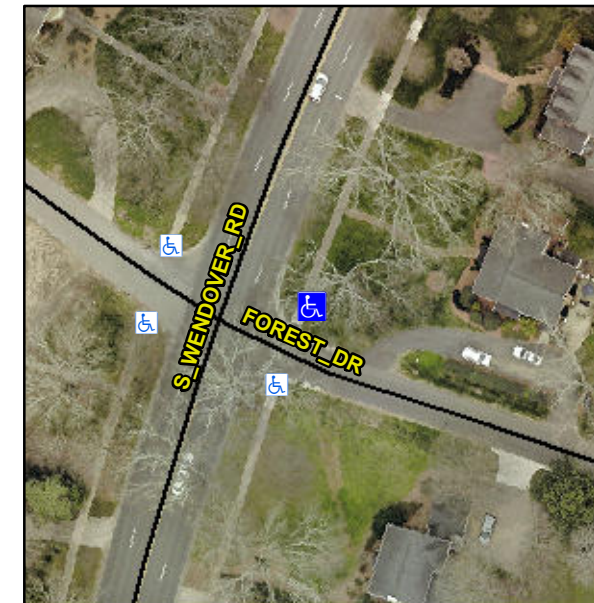
**Not Found, R304.2.2, R304.5.3**

Compliance	Description	Data	Compliance	Description	Data
N/A	Ramp Length (in)	63.0	No	Ramp Slope (%)	9.0
Yes	Ramp Width (in)	48.0	No	Ramp XSlope (%)	3.7
N/A	Flare Type LT	N/A	N/A	Flare Type RT	N/A
N/A	Flare Slope LT (%)	N/A	N/A	Flare Slope RT (%)	N/A
N/A	Flare Traversable LT?	N/A	N/A	Flare Traversable RT?	N/A
N/A	Landing Length (in)	N/A	N/A	DWS Provided?	N/A
N/A	Landing Width (in)	N/A	N/A	DWS Contrast?	N/A
N/A	Landing Slope (%)	N/A	N/A	DWS Length (in)	N/A
N/A	Landing X Slope (%)	N/A	N/A	DWS Full Width?	N/A
N/A	Landing Curb? (Y/N)	N/A	N/A	DWS Offset (in)	N/A
N/A	Shared Landing?	N/A			
N/A	Gutter Ponding?	N/A	N/A	Gutter Slope (%)	N/A
N/A	Gutter Lip Ht (in)	N/A	N/A	Gutter X Slope (%)	N/A
N/A	Painted X Walk1?	No	N/A	Painted X Walk2?	No
	X Walk 1 Direction	To NW		X Walk 2 Direction	To SW
N/A	X Walk 1 Width (in)	N/A	N/A	X Walk 2 Width (in)	N/A
	X Walk 1 Slope (%)	2.7		X Walk 2 Slope (%)	0.7
	X Walk 1 X Slope (%)	0.8		X Walk 2 X Slope (%)	3.7

N/A	Ramp inside XWalk1?	N/A	N/A	Ramp inside XWalk2?	N/A
	Road Slope (%)	3.0	N/A	Clear Space?	N/A
	Road X Slope (%)	1.6	N/A	Clear Space to XWalk (in)	N/A
N/A	Any Obstructions?	N/A	N/A	Storm Grate/Utility Hazard?	N/A
	Obstruction Type			Storm Grate/Utility Type	
		N/A			N/A
			Yes	Surface Condition? (G/P)	Good

**Remove & Replace Curb Ramp With Two New Directional Ramps or Equivalent.**
