# Access Compliance Report

## Public Rights-of-Way

### (Curb Ramps)

Intersection ID: 47820	Main Street: HERONS_POND_CT	Cross Street: ROYAL_FERN_LN	Location: NE
ADA ID: A445609576F1	Ramp Type: PerpDiag	Initial Pass/Fail: Fail	Overall Compliance: No
Severity Score: 50			
Codes/Mitigation Info/Possible Solution		Field Measurements/Component Compliance

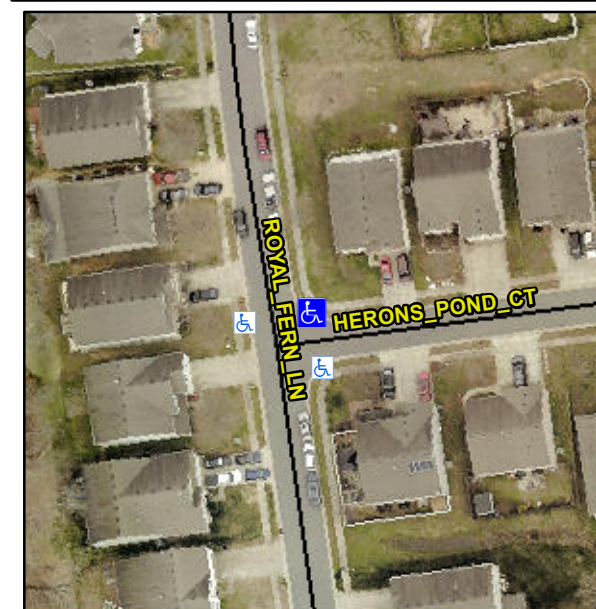
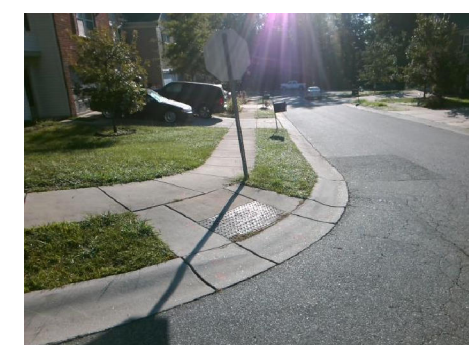
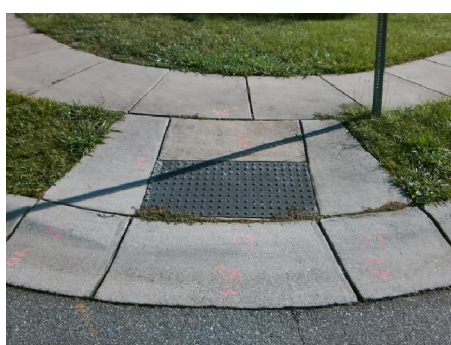
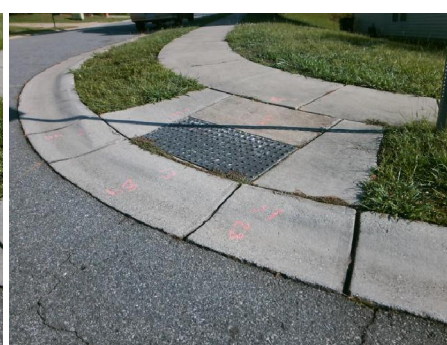
**Not Found, R304.2.2, R304.5.3**

Compliance	Description	Data	Compliance	Description	Data
N/A	Ramp Length (in)	49.5	No	Ramp Slope (%)	13.4
Yes	Ramp Width (in)	48.0	No	Ramp XSlope (%)	9.6
N/A	Flare Type LT	N/A	N/A	Flare Type RT	N/A
N/A	Flare Slope LT (%)	N/A	N/A	Flare Slope RT (%)	N/A
N/A	Flare Traversable LT?	N/A	N/A	Flare Traversable RT?	N/A
N/A	Landing Length (in)	N/A	N/A	DWS Provided?	N/A
N/A	Landing Width (in)	N/A	N/A	DWS Contrast?	N/A
N/A	Landing Slope (%)	N/A	N/A	DWS Length (in)	N/A
N/A	Landing X Slope (%)	N/A	N/A	DWS Full Width?	N/A
N/A	Landing Curb? (Y/N)	N/A	N/A	DWS Offset (in)	N/A
N/A	Shared Landing?	N/A			
N/A	Gutter Ponding?	N/A	N/A	Gutter Slope (%)	N/A
N/A	Gutter Lip Ht (in)	N/A	N/A	Gutter X Slope (%)	N/A
N/A	Painted X Walk1?	No	N/A	Painted X Walk2?	No
	X Walk 1 Direction	To W		X Walk 2 Direction	To S
N/A	X Walk 1 Width (in)	N/A	N/A	X Walk 2 Width (in)	N/A
	X Walk 1 Slope (%)	4.0		X Walk 2 Slope (%)	2.8
	X Walk 1 X Slope (%)	6.3		X Walk 2 X Slope (%)	5.7

N/A	Ramp inside XWalk1?	N/A	N/A	Ramp inside XWalk2?	N/A
	Road Slope (%)	8.9	N/A	Clear Space?	N/A
	Road X Slope (%)	1.3	N/A	Clear Space to XWalk (in)	N/A
N/A	Any Obstructions?	N/A	N/A	Storm Grate/Utility Hazard?	N/A
	Obstruction Type			Storm Grate/Utility Type	
		N/A			N/A
		Yes		Surface Condition? (G/P)	Good

**Remove & Replace Curb Ramp With Two New Directional Ramps or Equivalent.**
