Access Compliance Report

Public Rights-of-Way

(Curb Ramps)

Intersection ID: 51011	Main Street: TREMONT_PLACE_RD	Cross Street: BENDING_BRANCH_RD	Location: E
ADA ID: A447B2409EBB	Ramp Type: Perp	Initial Pass/Fail: Fail	Overall Compliance: No
Severity Score: 37.5			
Codes/Mitigation Info/Possible Solution		Field Measurements/Component Compliance

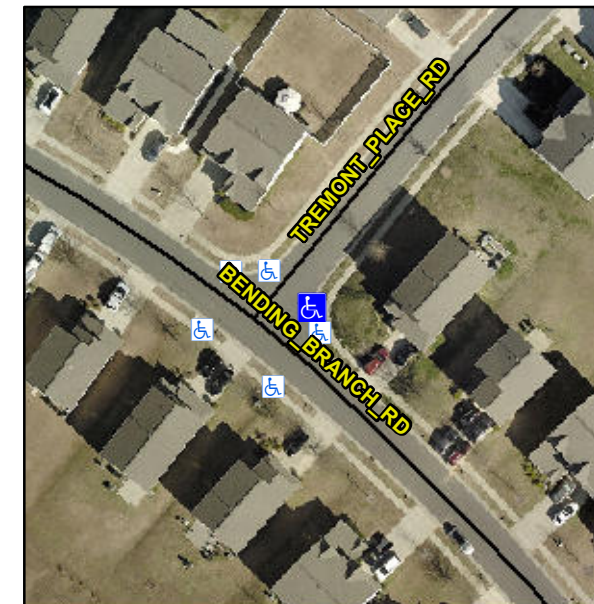
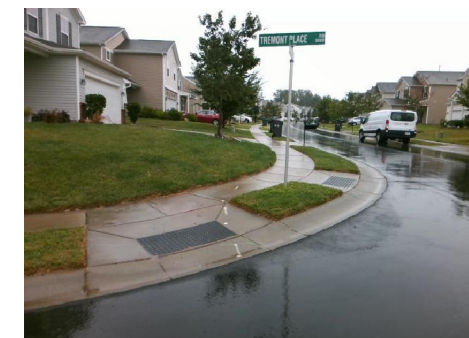
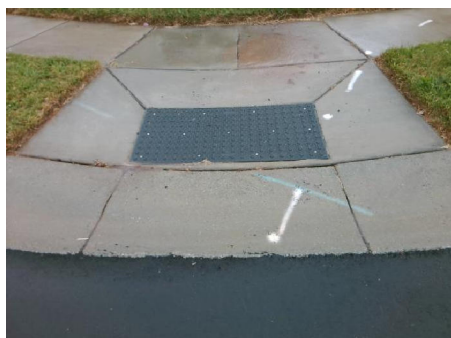
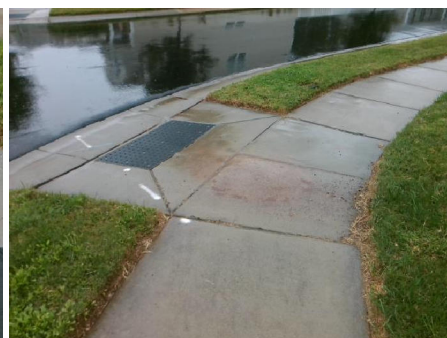
Compliance	Description	Data	Compliance	Description	Data
N/A	Ramp Length (in)	49.0	No	Ramp Slope (%)	11.9
Yes	Ramp Width (in)	48.0	No	Ramp XSlope (%)	8.8
N/A	Flare Type LT	N/A	N/A	Flare Type RT	N/A
N/A	Flare Slope LT (%)	N/A	N/A	Flare Slope RT (%)	N/A
N/A	Flare Traversable LT?	N/A	N/A	Flare Traversable RT?	N/A
N/A	Landing Length (in)	N/A	N/A	DWS Provided?	N/A
N/A	Landing Width (in)	N/A	N/A	DWS Contrast?	N/A
N/A	Landing Slope (%)	N/A	N/A	DWS Length (in)	N/A
N/A	Landing X Slope (%)	N/A	N/A	DWS Full Width?	N/A
N/A	Landing Curb? (Y/N)	N/A	N/A	DWS Offset (in)	N/A
N/A	Shared Landing?	N/A			
N/A	Gutter Ponding?	N/A	N/A	Gutter Slope (%)	N/A
N/A	Gutter Lip Ht (in)	N/A	N/A	Gutter X Slope (%)	N/A
N/A	Painted X Walk1?	No	N/A	Painted X Walk2?	N/A
	X Walk 1 Direction	To NW		X Walk 2 Direction	N/A
N/A	X Walk 1 Width (in)	N/A	N/A	X Walk 2 Width (in)	N/A
	X Walk 1 Slope (%)	0.0		X Walk 2 Slope (%)	N/A
	X Walk 1 X Slope (%)	3.0		X Walk 2 X Slope (%)	N/A

N/A	Ramp inside XWalk1?	N/A	N/A	Ramp inside XWalk2?	N/A
	Road Slope (%)	N/A	N/A	Clear Space?	N/A
	Road X Slope (%)	N/A	N/A	Clear Space to XWalk (in)	N/A
N/A	Any Obstructions?	N/A	N/A	Storm Grate/Utility Hazard?	N/A
	Obstruction Type			Storm Grate/Utility Type	
		N/A			N/A
			Yes	Surface Condition? (G/P)	Good

Possible Solutions:

Remove & Replace Entire Ramp.

R304.2.2, R304.5.3
