Access Compliance Report

Public Rights-of-Way

(Curb Ramps)

Intersection ID: 47835	Main Street: CAMP_VERDE_LN	Cross Street: CACTUS_VALLEY_RD	Location: NE
ADA ID: A448905C45EE	Ramp Type: PerpDiag	Initial Pass/Fail: Fail	Overall Compliance: No
Severity Score: 21.25			
Codes/Mitigation Info/Possible Solution		Field Measurements/Component Compliance

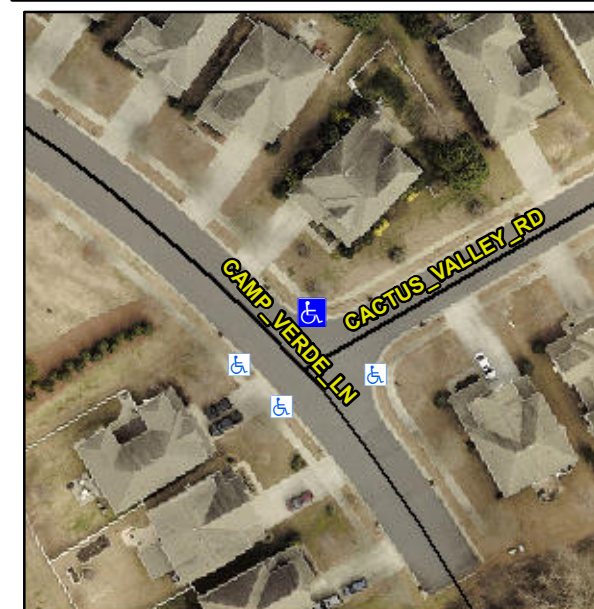
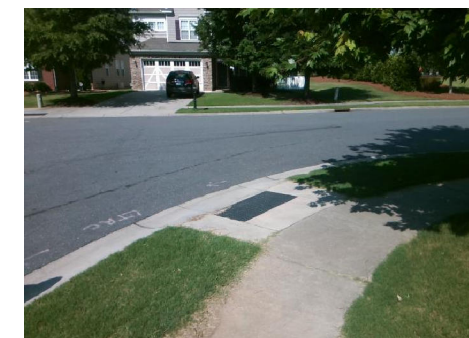
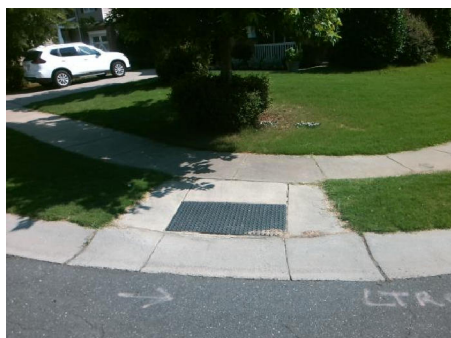
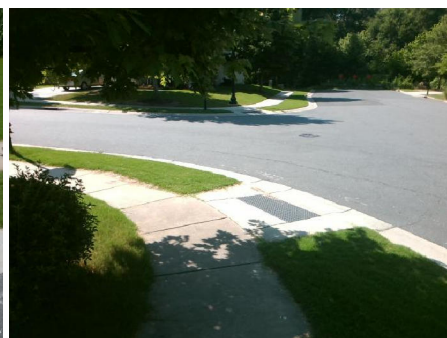
Not Found, R304.5.1, R304.2.2

Compliance	Description	Data	Compliance	Description	Data
N/A	Ramp Length (in)	48.0	No	Ramp Slope (%)	8.9
No	Ramp Width (in)	46.5	Yes	Ramp XSlope (%)	0.4
N/A	Flare Type LT	N/A	N/A	Flare Type RT	N/A
N/A	Flare Slope LT (%)	N/A	N/A	Flare Slope RT (%)	N/A
N/A	Flare Traversable LT?	N/A	N/A	Flare Traversable RT?	N/A
N/A	Landing Length (in)	N/A	N/A	DWS Provided?	N/A
N/A	Landing Width (in)	N/A	N/A	DWS Contrast?	N/A
N/A	Landing Slope (%)	N/A	N/A	DWS Length (in)	N/A
N/A	Landing X Slope (%)	N/A	N/A	DWS Full Width?	N/A
N/A	Landing Curb? (Y/N)	N/A	N/A	DWS Offset (in)	N/A
N/A	Shared Landing?	N/A			
N/A	Gutter Ponding?	N/A	N/A	Gutter Slope (%)	N/A
N/A	Gutter Lip Ht (in)	N/A	N/A	Gutter X Slope (%)	N/A
N/A	Painted X Walk1?	No	N/A	Painted X Walk2?	No
	X Walk 1 Direction	To SW		X Walk 2 Direction	To SE
N/A	X Walk 1 Width (in)	N/A	N/A	X Walk 2 Width (in)	N/A
	X Walk 1 Slope (%)	1.5		X Walk 2 Slope (%)	0.3
	X Walk 1 X Slope (%)	0.1		X Walk 2 X Slope (%)	1.4

N/A	Ramp inside XWalk1?	N/A	N/A	Ramp inside XWalk2?	N/A
	Road Slope (%)	0.7	N/A	Clear Space?	N/A
	Road X Slope (%)	1.2	N/A	Clear Space to XWalk (in)	N/A
N/A	Any Obstructions?	N/A	N/A	Storm Grate/Utility Hazard?	N/A
	Obstruction Type			Storm Grate/Utility Type	
		N/A			N/A
			Yes	Surface Condition? (G/P)	Good

Remove & Replace Curb Ramp With Two New Directional Ramps or Equivalent.
