Access Compliance Report

Public Rights-of-Way

(Curb Ramps)

Intersection ID: 10673	Main Street: MAHOPAC_ST	Cross Street: STATE_ST	Location:	W
ADA ID: A45D93111328	Ramp Type: Perp	Initial Pass/Fail: Fail	Overall Compliance: No	Severity Score: 22.5
Codes/Mitigation Info/Possible Solution		Field Measurements/Component Compliance

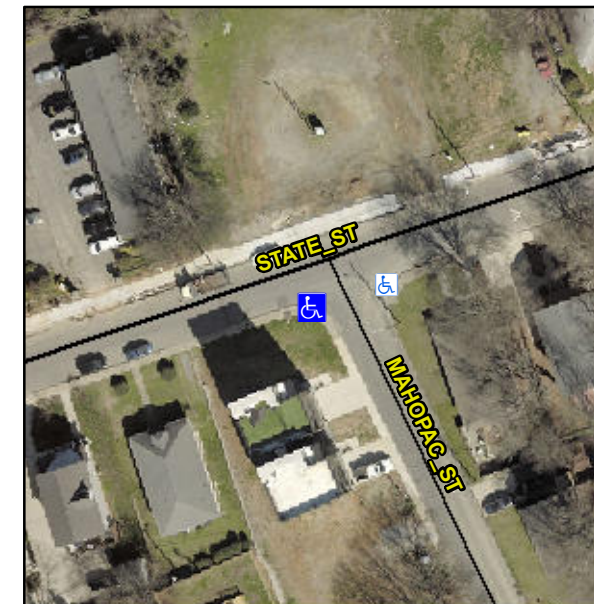
R304.5.1, R304.2.2, R304.5.3

Compliance	Description	Data	Compliance	Description	Data
N/A	Ramp Length (in)	68.0	No	Ramp Slope (%)	9.2
No	Ramp Width (in)	38.0	No	Ramp XSlope (%)	3.6
N/A	Flare Type LT	N/A	N/A	Flare Type RT	N/A
N/A	Flare Slope LT (%)	N/A	N/A	Flare Slope RT (%)	N/A
N/A	Flare Traversable LT?	N/A	N/A	Flare Traversable RT?	N/A
N/A	Landing Length (in)	N/A	N/A	DWS Provided?	N/A
N/A	Landing Width (in)	N/A	N/A	DWS Contrast?	N/A
N/A	Landing Slope (%)	N/A	N/A	DWS Length (in)	N/A
N/A	Landing X Slope (%)	N/A	N/A	DWS Full Width?	N/A
N/A	Landing Curb? (Y/N)	N/A	N/A	DWS Offset (in)	N/A
N/A	Shared Landing?	N/A			
N/A	Gutter Ponding?	N/A	N/A	Gutter Slope (%)	N/A
N/A	Gutter Lip Ht (in)	0.5	N/A	Gutter X Slope (%)	N/A
N/A	Painted X Walk1?	No	N/A	Painted X Walk2?	N/A
	X Walk 1 Direction	To E		X Walk 2 Direction	N/A
N/A	X Walk 1 Width (in)	N/A	N/A	X Walk 2 Width (in)	N/A
	X Walk 1 Slope (%)	4.5		X Walk 2 Slope (%)	N/A
	X Walk 1 X Slope (%)	0.5		X Walk 2 X Slope (%)	N/A

Remove & Replace Entire Ramp.

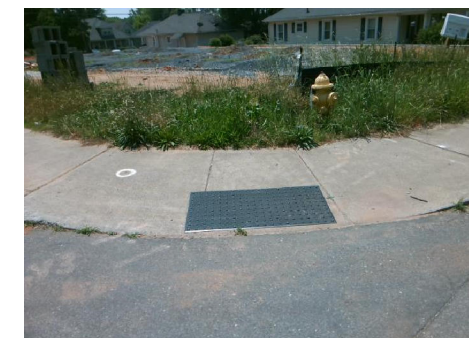
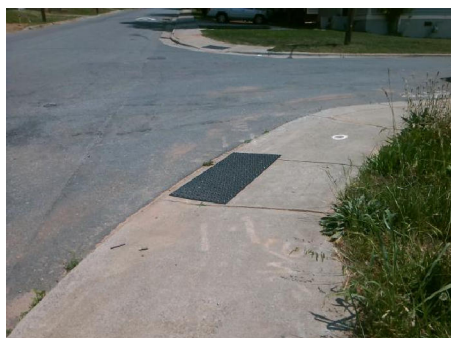
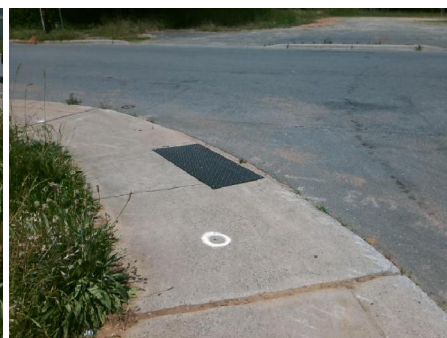
N/A	Ramp inside XWalk1?	N/A	N/A	Ramp inside XWalk2?	N/A
	Road Slope (%)	N/A	N/A	Clear Space?	N/A
	Road X Slope (%)	N/A	N/A	Clear Space to XWalk (in)	N/A
N/A	Any Obstructions?	N/A	N/A	Storm Grate/Utility Hazard?	N/A
	Obstruction Type			Storm Grate/Utility Type	
		N/A			N/A
			Yes	Surface Condition? (G/P)	Good
