# Access Compliance Report

## Public Rights-of-Way

### (Curb Ramps)

Intersection ID: 9040	Main Street: BOYD_ST	Cross Street: HARRISON_ST	Location:	N
ADA ID: A46ED8872EB1	Ramp Type: Perp	Initial Pass/Fail: Fail	Overall Compliance: No	Severity Score: 21.25
Codes/Mitigation Info/Possible Solution		Field Measurements/Component Compliance

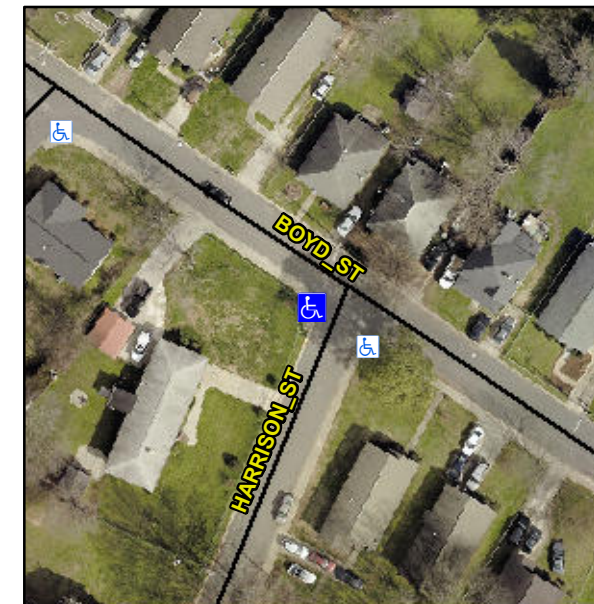
**Not Found, R304.5.1, R304.2.2**

Compliance	Description	Data	Compliance	Description	Data
N/A	Ramp Length (in)	49.0	No	Ramp Slope (%)	8.4
No	Ramp Width (in)	41.0	Yes	Ramp XSlope (%)	0.3
N/A	Flare Type LT	N/A	N/A	Flare Type RT	N/A
N/A	Flare Slope LT (%)	N/A	N/A	Flare Slope RT (%)	N/A
N/A	Flare Traversable LT?	N/A	N/A	Flare Traversable RT?	N/A
N/A	Landing Length (in)	N/A	N/A	DWS Provided?	N/A
N/A	Landing Width (in)	N/A	N/A	DWS Contrast?	N/A
N/A	Landing Slope (%)	N/A	N/A	DWS Length (in)	N/A
N/A	Landing X Slope (%)	N/A	N/A	DWS Full Width?	N/A
N/A	Landing Curb? (Y/N)	N/A	N/A	DWS Offset (in)	N/A
N/A	Shared Landing?	N/A			
N/A	Gutter Ponding?	N/A	N/A	Gutter Slope (%)	N/A
N/A	Gutter Lip Ht (in)	0.5	N/A	Gutter X Slope (%)	N/A
N/A	Painted X Walk1?	No	N/A	Painted X Walk2?	N/A
	X Walk 1 Direction	To SE		X Walk 2 Direction	N/A
N/A	X Walk 1 Width (in)	N/A	N/A	X Walk 2 Width (in)	N/A
	X Walk 1 Slope (%)	1.6		X Walk 2 Slope (%)	N/A
	X Walk 1 X Slope (%)	0.4		X Walk 2 X Slope (%)	N/A

N/A	Ramp inside XWalk1?	N/A	N/A	Ramp inside XWalk2?	N/A
	Road Slope (%)	N/A	N/A	Clear Space?	N/A
	Road X Slope (%)	N/A	N/A	Clear Space to XWalk (in)	N/A
N/A	Any Obstructions?	N/A	N/A	Storm Grate/Utility Hazard?	N/A
	Obstruction Type			Storm Grate/Utility Type	
		N/A			N/A
			Yes	Surface Condition? (G/P)	Good

Possible Solutions:

**Remove & Replace Entire Ramp.**

Total Cost: \$ 1850.00
