# Access Compliance Report

## Public Rights-of-Way

### (Curb Ramps)

| Intersection ID: N/A | Main Street: TRYON_ST | Cross Street: ANANDALE_DR | Location: SE |

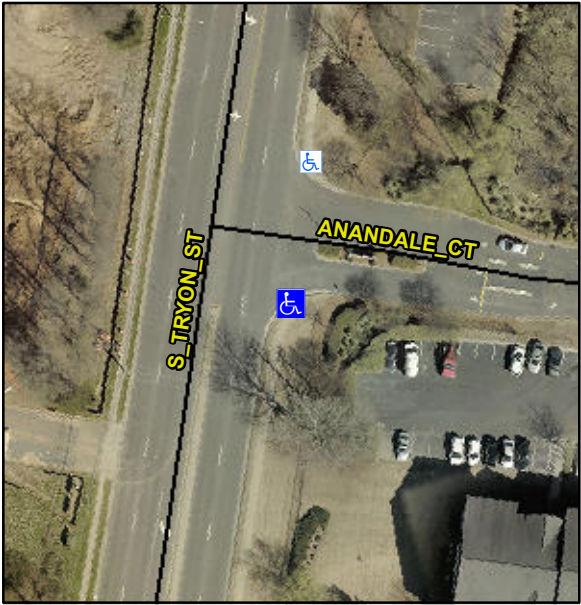
| ADA ID: A479D8E71FF2 | Ramp Type: PerpDiag | Initial Pass/Fail: Fail | Overall Compliance: No |
| Severity Score: 8.75 | | | |

| | Remove & Replace Curb Ramp With Two New Directional Ramps or Equivalent. | N/A | Ramp Length (in) | 91.0 | Yes | Ramp Slope (%) | 5.6 |
| | | No | Ramp Width (in) | 45.0 | Yes | Ramp XSlope (%) | 1.7 |
| <p>Surveyor Notes:</p> <p>N/A</p> <p>PROW/ADA:</p> <p>Not Found, R304.5.1</p> | | | Road Slope (%) | 0.9 | N/A | Clear Space? | N/A |

| | Possible Solutions: | | | | | | |
