# Access Compliance Report

## Public Rights-of-Way

### (Curb Ramps)

Intersection ID: 48950	Main Street: DAVID_JENNINGS_AV	Cross Street: BONROI_AV	Location: W
ADA ID: A47C6D2E7AF3	Ramp Type: Combination1	Initial Pass/Fail: Fail	Overall Compliance: No
Severity Score: 33.75			
Codes/Mitigation Info/Possible Solution		Field Measurements/Component Compliance

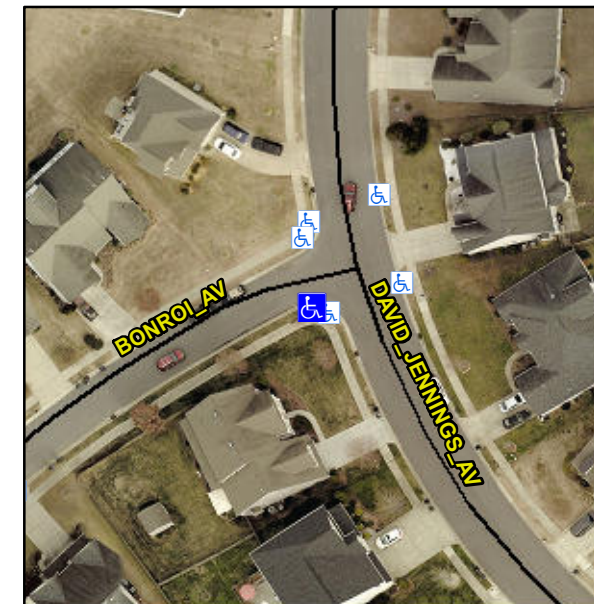
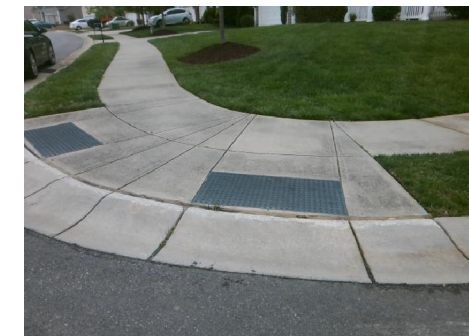
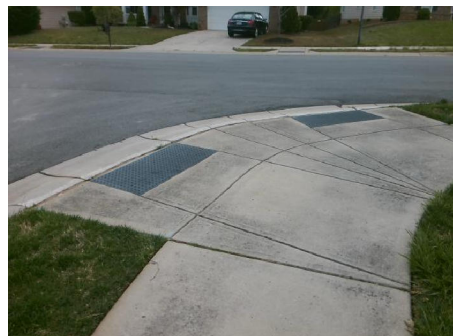
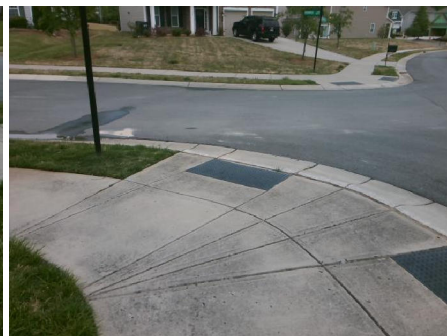
**CURB GAP 1.5**

**Not Found, R304.5.1, R304.5.3**

Compliance	Description	Data	Compliance	Description	Data
N/A	Ramp Length LT (in)	3.0	N/A	Ramp Length RT (in)	1.5
Yes	Ramp Width LT (in)	61.5	Yes	Ramp Width RT (in)	58.0
Yes	Ramp Slope LT (%)	6.3	Yes	Ramp Slope RT (%)	5.7
No	Ramp XSlope LT (%)	3.3	No	Ramp XSlope RT (%)	2.1
N/A	Ramp Length (in)	49.0	Yes	Ramp Slope (%)	3.7
No	Ramp Width (in)	47.0	No	Ramp XSlope (%)	12.1
N/A	Flare Type LT	N/A	N/A	Flare Type RT	N/A
N/A	Flare Slope LT (%)	N/A	N/A	Flare Slope RT (%)	N/A
N/A	Flare Traversable LT?	N/A	N/A	Flare Traversable RT?	N/A
N/A	Landing Length (in)	N/A	N/A	DWS Provided?	N/A
N/A	Landing Width (in)	N/A	N/A	DWS Contrast?	N/A
N/A	Landing Slope (%)	N/A	N/A	DWS Length (in)	N/A
N/A	Landing X Slope (%)	N/A	N/A	DWS Full Width?	N/A
N/A	Landing Curb? (Y/N)	N/A	N/A	DWS Offset (in)	N/A
N/A	Shared Landing?	N/A			
N/A	Gutter Ponding?	N/A	N/A	Gutter Slope (%)	N/A
N/A	Gutter Lip Ht (in)	N/A	N/A	Gutter X Slope (%)	N/A
N/A	Painted X Walk1?	No	N/A	Painted X Walk2?	N/A

X Walk 1 Direction	To N		X Walk 2 Direction	N/A
	X Walk 1 Width (in)	N/A		X Walk 2 Width (in)	N/A
	X Walk 1 Slope (%)	3.2		X Walk 2 Slope (%)	N/A
	X Walk 1 X Slope (%)	1.8		X Walk 2 X Slope (%)	N/A
N/A	Ramp inside XWalk1?	N/A	N/A	Ramp inside XWalk2?	N/A
	Road Slope (%)	N/A		Clear Space?	N/A
	Road X Slope (%)	N/A	N/A	Clear Space to XWalk (in)	N/A
			N/A	Any Obstruction?	N/A
				Obstruction Type	N/A
			N/A	Storm Grate/Utility Hazard?	N/A
				Storm Grate/Utility Type	N/A
			Yes	Surface Condition? (G/P)	Good
				Curb Slope (%)	16.0

**Remove & Replace Entire Ramp.**
