# Access Compliance Report

## Public Rights-of-Way

| Intersection ID: 10393 | Main Street: LIMA_AV | Cross Street: ROZZELLES_FERRY_RD | Location: SW |
| ADA ID: A480FEBE42C4 | Ramp Type: BlendTrans1 | Initial Pass/Fail: Pass | Overall Compliance: No |

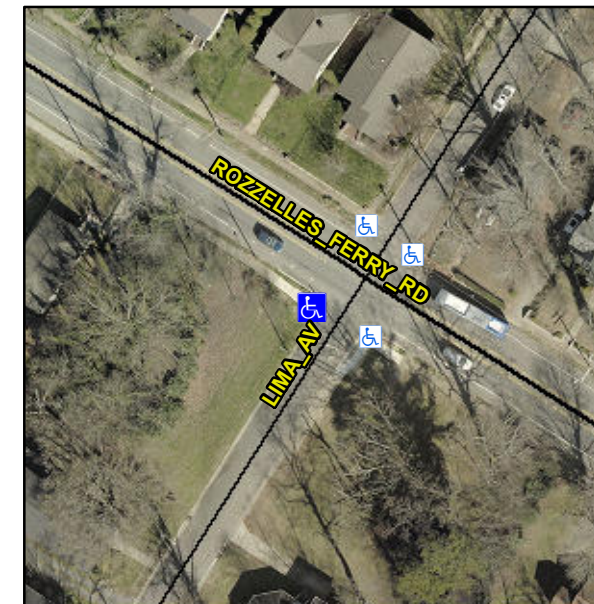
**LT PART OF RAMP IS GRAVEL**

**Not Found, R304.5.3, R304.2.2-Perp, R304.3.2-Para, R305, R304.5.4**

| Compliance | Description | Data | Compliance | Description | Data |
|---|---|---|---|---|---|
| Yes | Ramp Width (in) | 48.0 | No | BlendTrans XSlope (%) | 4.6 |
| Yes | Landing Length (in) | 84.0 | No | DWS Provided? | No |
| No | Landing Slope (%) | 3.7 | N/A | DWS Length (in) | N/A |
| No | Landing X Slope (%) | 2.6 | N/A | DWS Full Width? | No |

**Remove & Replace Curb Ramp With Two New Directional Ramps or Equivalent. Remove & Replace Gutter.**

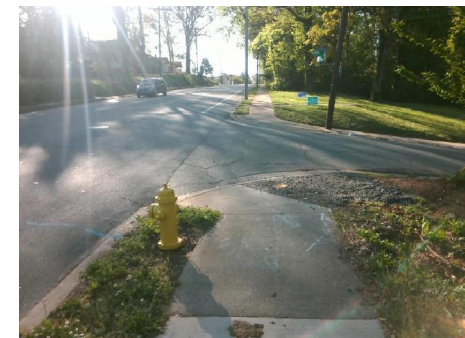
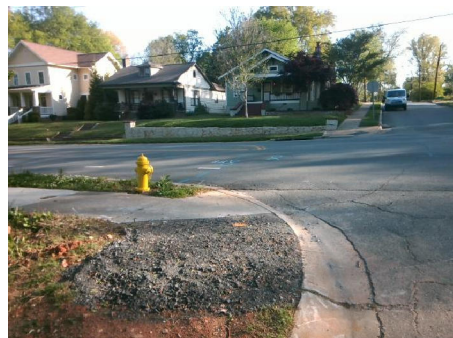
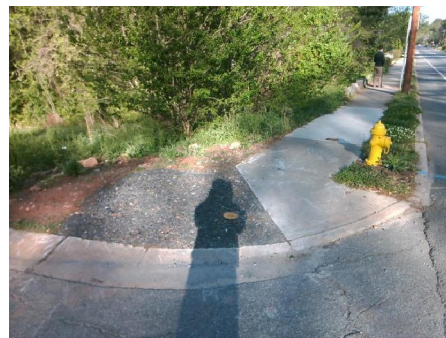
| Compliance | Description | Data | Compliance | Description | Data |
|---|---|---|---|---|---|
| Yes | Gutter Ponding? | No | No | Gutter Slope (%) | 11.7 |

Total Cost: \$ 3950.00
