# Access Compliance Report

## Public Rights-of-Way (Curb Ramps)

| Intersection ID: 43531 | Main Street: SPRING_RAIN_CT | Cross Street: PLANTERS_WATCH_DR | Location: SW |
| ADA ID: A484A9F987BB | Ramp Type: BlendTrans1 | Initial Pass/Fail: Fail | Overall Compliance: No |

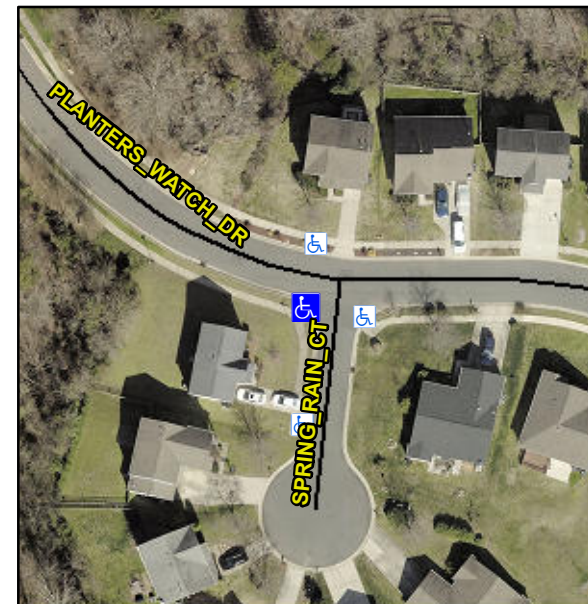
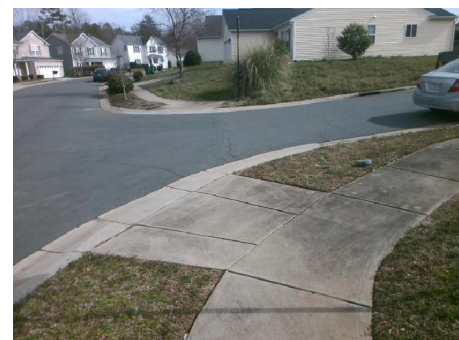
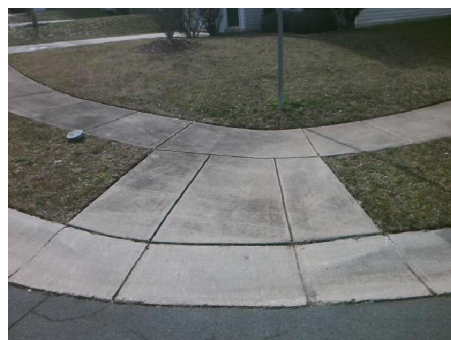
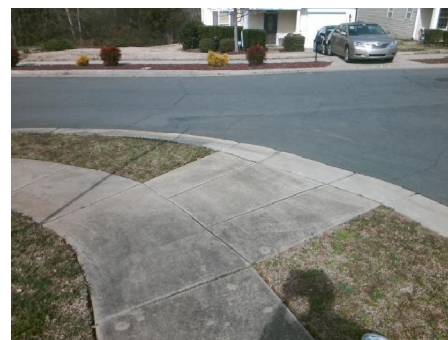
| | | Severity Score: 30 | |

| Compliance | Description | Data | Compliance | Description | Data |
|---|---|---|---|---|---|
| No | Ramp Width (in) | 32.0 | No | BlendTrans XSlope (%) | 5.4 |

**Remove & Replace Curb Ramp With Two New Directional Ramps or Equivalent.**

**R304.5.1, R304.5.3**
